N1092D-01

Modification Recommended Service Note

N1092D DCA-M Sampling Oscilloscope (Quad Optical Channel)

Replace the left front panel overlay that shows the new clock input level at 1.4 Vp-p Max.

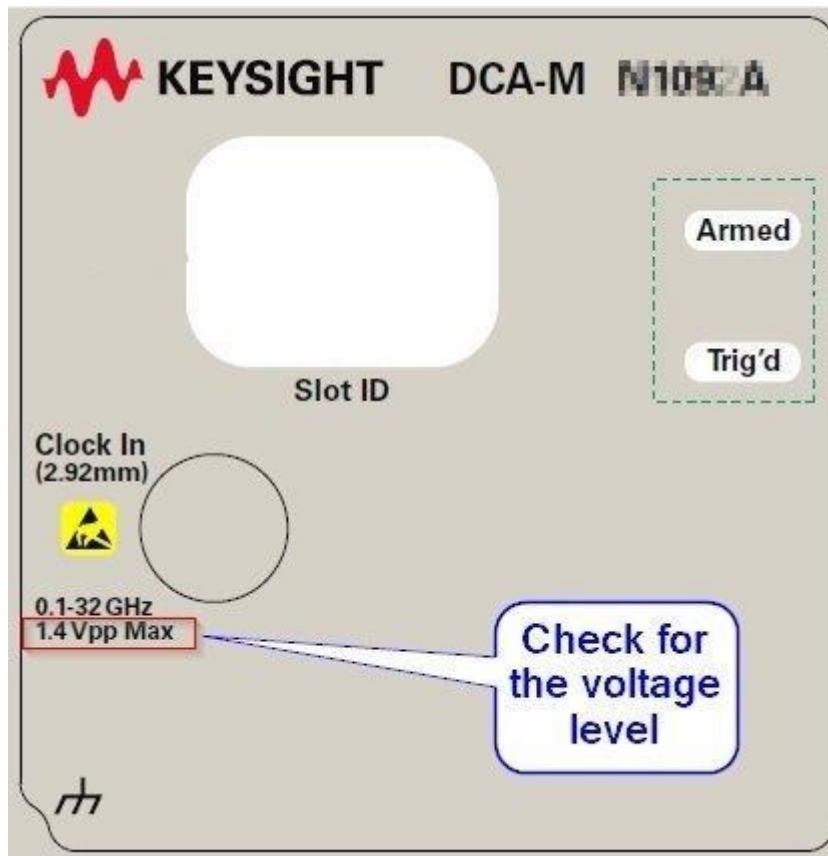
In May 2018, the clock's input port maximum signal voltage changed from 2.0 Vp-p (old value) to 1.4 Vp-p (new value). This is very sensitive circuitry and this change provides additional margin to reduce risk of damage to the instrument.

Figure 1 Updated overlay - should say 1.4 Vpp Max

If the front left panel overlay shows 2 Vp-p (old value), remove the old overlay and replace it with the new overlay that shows 1.4 Vp-p (new value). If the customer has added any asset tags, or other customer information to the old left front panel overlay, it is recommended to send back the old overlay to the customer after it has been removed.
