N2830A-02

Modification Recommended Service Note

N2830A 4 GHz InfiniiMax III+ Series Probe Amplifier

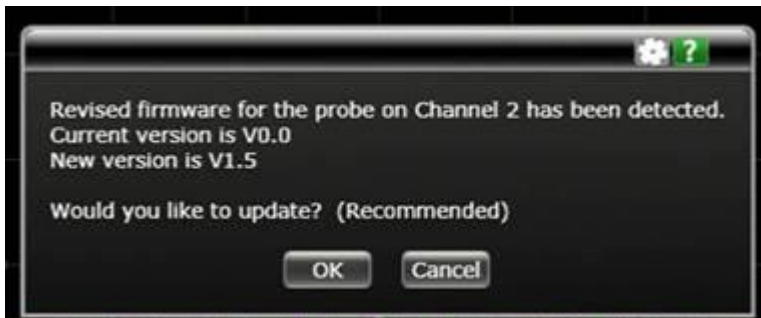
With older Infiniium Application SW versions, the probes microcontroller address can inadvertently be re-written. This will cause the probe to have an error message displayed on the scope when attached.

1. Ask the customer if he/she has seen the following message when plugging his/her probe onto an oscilloscope:

2. Regardless of the customer's answer to the question, plug the customer's probe onto a Service Center scope with software version 06.20.00701 or later.
3. If the Customer said No in step 1 or was unsure: tell the customer that Keysight recommends downloading latest scope software version—Version 06.20.00701 or later. Continue with standard procedure.
4. If the Customer said Yes, the probe appears to function normally on the scope, and it passes calibration, the probe has been fixed. Send the original probe back to the customer, and tell the customer that Keysight recommends an upgrade to oscilloscope software—Version 06.20.00701 or later to prevent this issue from re-occurring to their probe.
