**N3381A-02**

# **S E R V I C E N O T E**

## **N3381A PNA Microwave Network Analyzers**

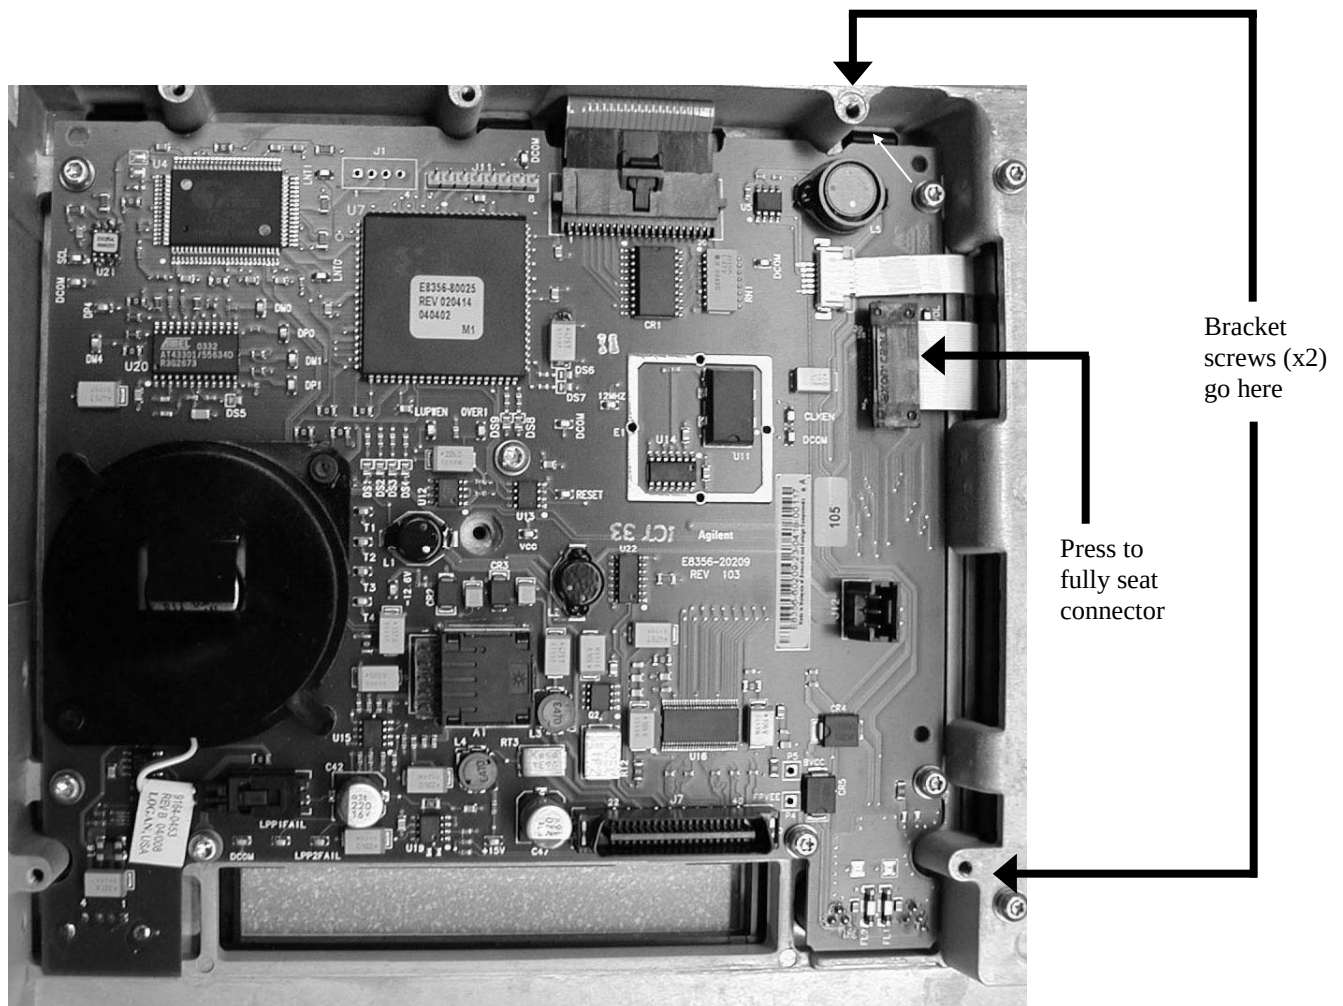
**Figure 1: A3 Front Panel Interface Board Assy without the Bracket**

A connector of the ribbon cable (Agilent part number 8120-8409) that joins the front panel display to the front panel interface board can loosen, causing a display failure, unless a new bracket is installed. Because the failure rate has been very low, it is recommended that the bracket be installed only when there is an additional reason to remove the PNA front panel.

1. Refer to Figure 1 in this document:
  - Press down firmly on the ribbon cable's black connector.
  - Locate the two tapped holes for the bracket screws.
2. As shown in Figure 2 in this document, position the bracket so that its holes line-up with the two holes you located in the previous step.
3. Hand-start the two screws, and then torque both to 9 in-lbs.
4. Reinstall the PNA Front Panel by following the Service Guide instructions in the "Replacement Procedure." This is located on the same page as the "Removal Procedure" used previously in step 7.
