**N3382A-02**

# **S E R V I C E                      N O T E**

## **N3382A PNA Microwave Network Analyzers**

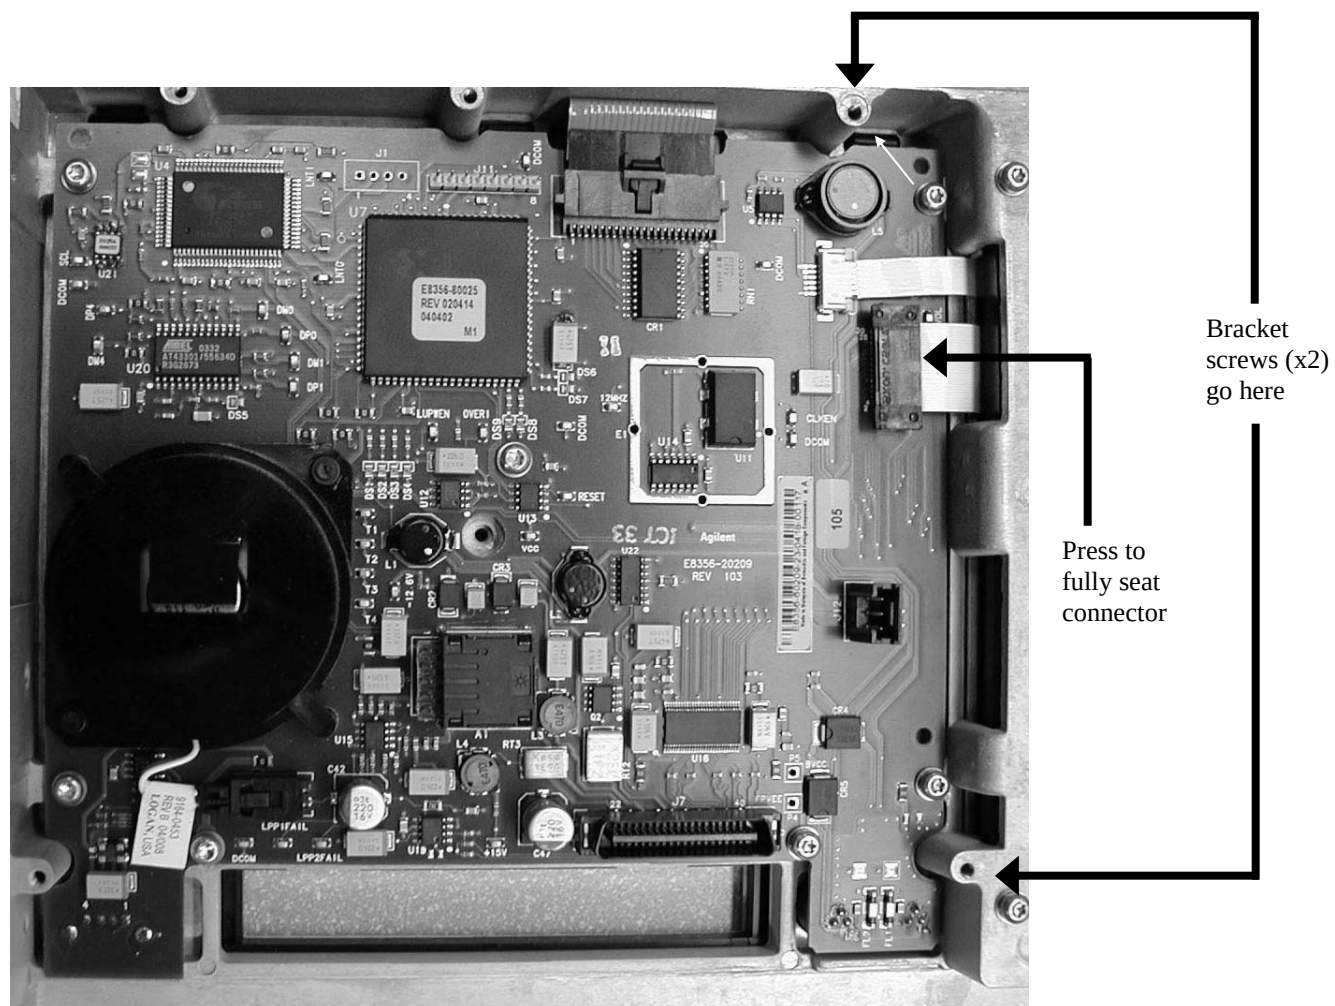
**Figure 1:** A3 Front Panel Interface Board Assy without the Bracket

A connector of the ribbon cable (Agilent part number 8120-8409) that joins the front panel display to the front panel interface board can loosen, causing a display failure, unless a new bracket is installed. Because the failure rate has been very low, it is recommended that the bracket be installed only when there is an additional reason to remove the PNA front panel.

1. Refer to Figure 1 in this document:
  - Press down firmly on the ribbon cable's black connector.
  - Locate the two tapped holes for the bracket screws.
2. As shown in Figure 2 in this document, position the bracket so that its holes line-up with the two holes you located in the previous step.
3. Hand-start the two screws, and then torque both to 9 in-lbs.
4. Reinstall the PNA Front Panel by following the Service Guide instructions in the "Replacement Procedure." This is located on the same page as the "Removal Procedure" used previously in step 7.
