N3383A-01C

S E R V I C E N O T E

N3383A PNA Series RF Network Analyzers

Serial Numbers: 00000000 thru 46999999

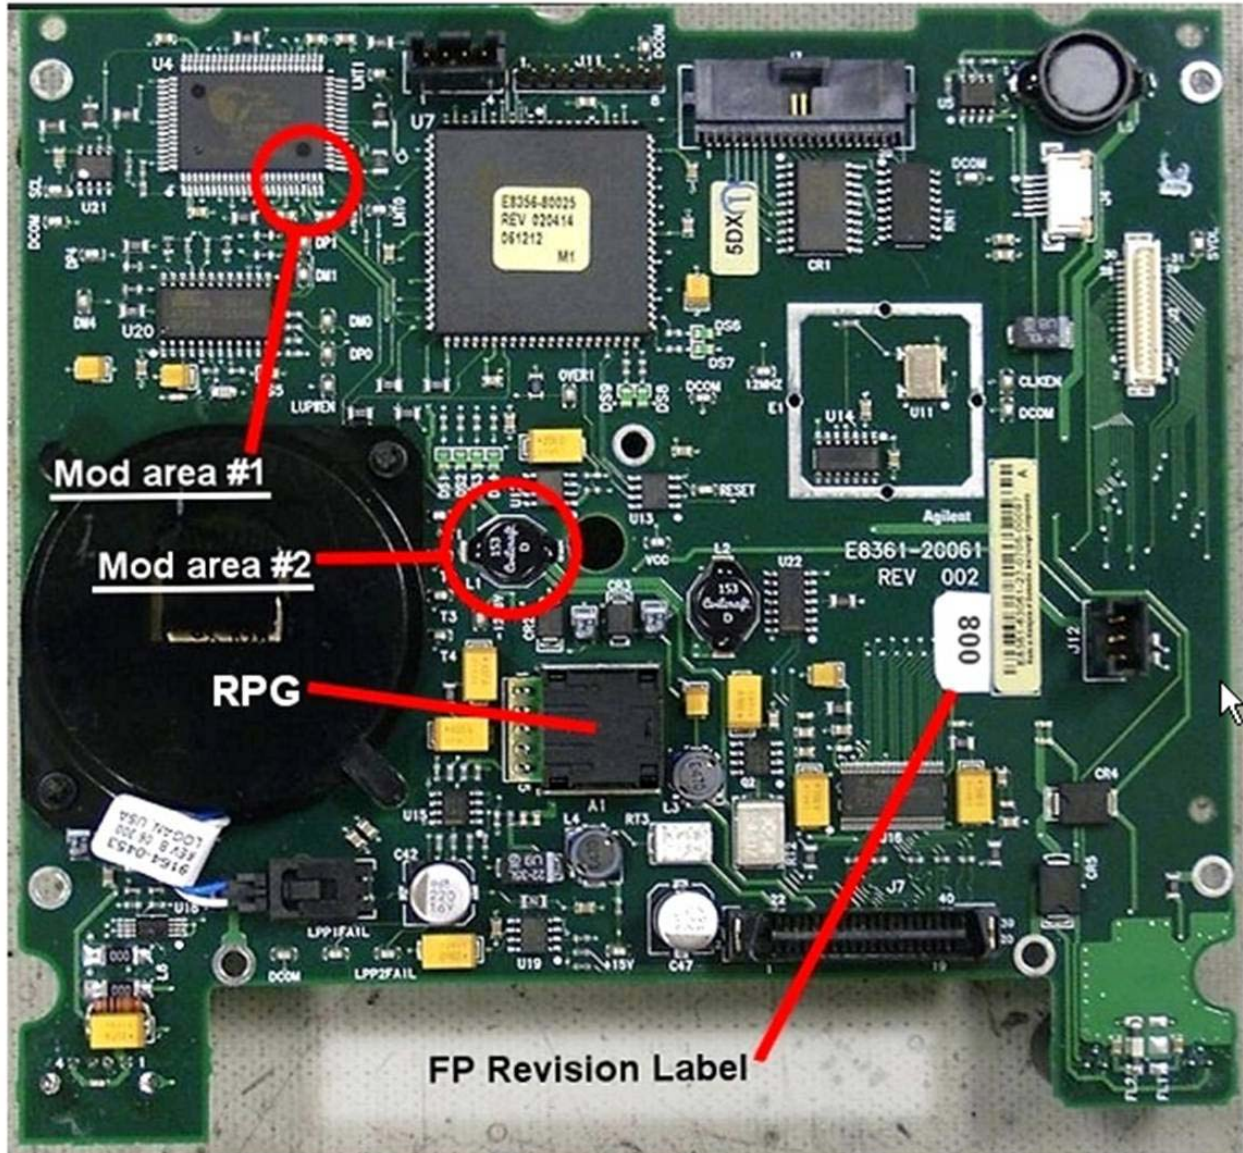
Refer to Figure 1 for the two modification areas to be addressed. Note that while this picture happens to show the FPI board completely removed from the front frame assembly, this is not necessary to perform the required modifications.

- Modification #1 consists of shorting two pins of U4 together with a small amount of solder.
- Modification #2 consist of removing L1.

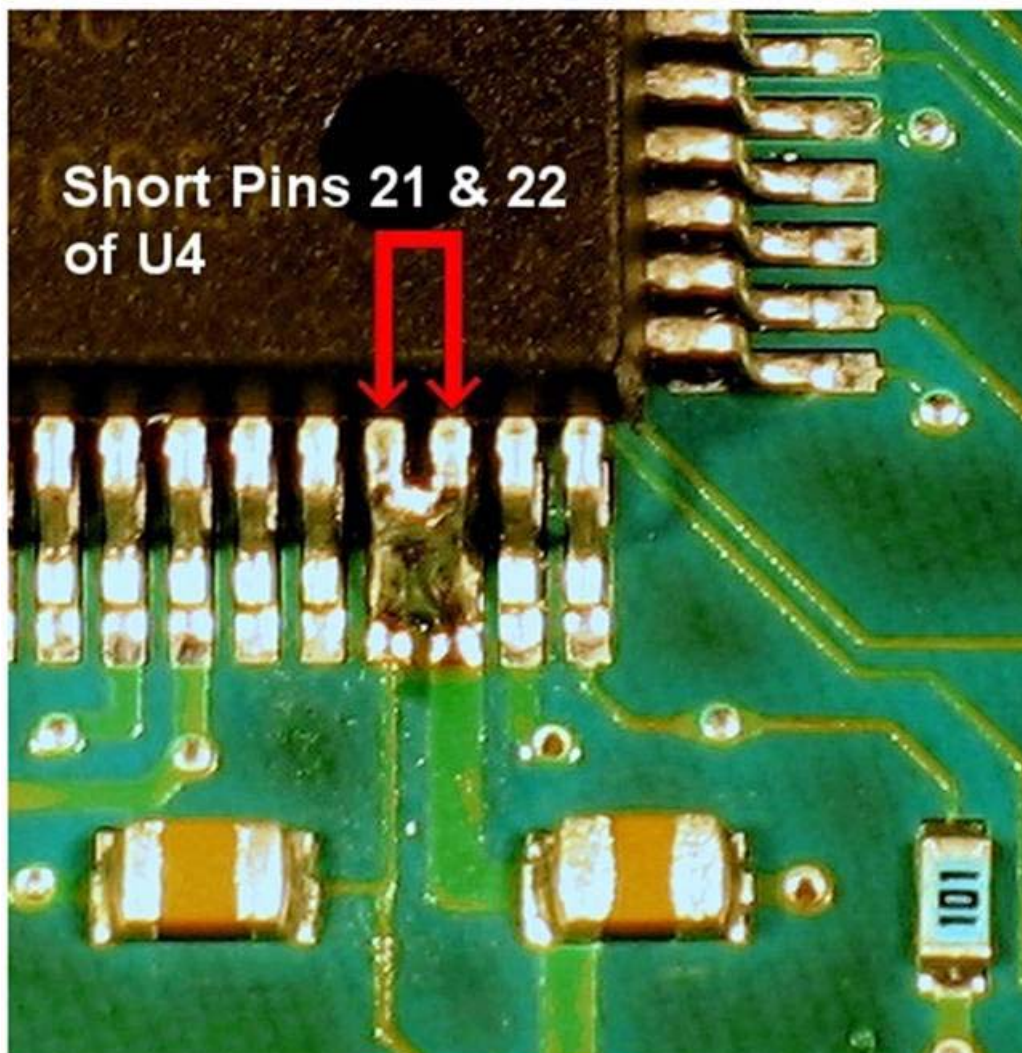
Both intermittent problems have been traced to an incorrect voltage applied to a pin on the U4 IC.

Carefully solder pins 21 and 22 together on U4. Refer to Figure 2 for the exact location. Use care so that no other pins are shorted. Use of a very fine tip soldering iron is recommended and a large work-task magnifying glass is very helpful.
