N4691D-02

# Modification Recommended Service Note

## N4691D Electronic Calibration Module (ECal)

Serial Numbers: MY57450000-MY99999999

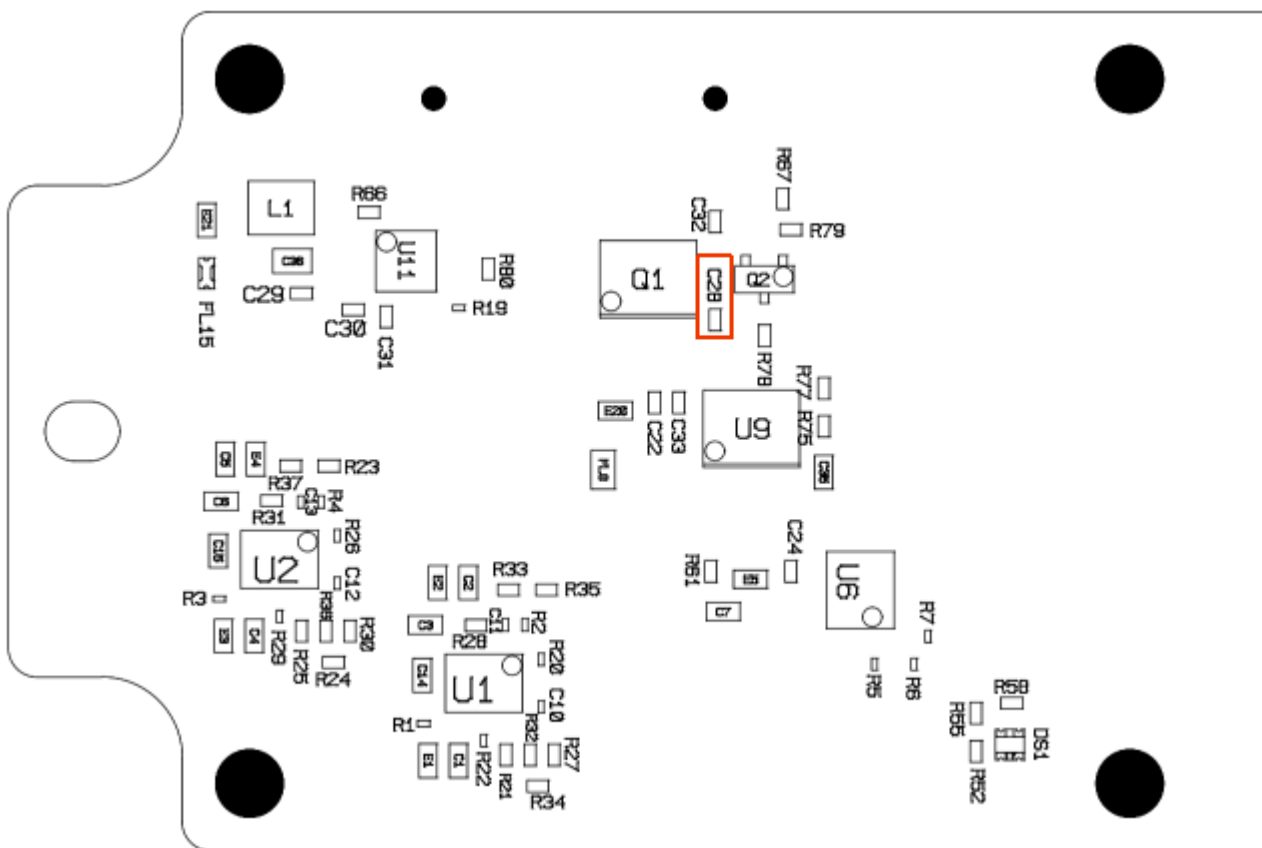
The heater circuit in the N469xD ECal modules was initially designed with a dampening capacitor. It was found in a small number of ECal modules that a resonance can develop in this circuit after the modules is warmed up. This resonance can cause an RF tone between 140 MHz and 150 MHz to be injected onto the signal path.

Open the ECal module and remove the N4690-63004 printed circuit board. On this board, locate the C28 capacitor indicated here:

If this capacitor has been removed, no further action is required. Reassemble the ECal module.

If this capacitor exists on this board, this capacitor should be carefully unsoldered and removed, or the N4690-63004 printed circuit assembly should be replaced. Once this is done, reassemble the ECal module.
