N4694D-02

Modification Recommended Service Note

N4694D Electronic Calibration Module (ECal)

Serial Numbers: MY57450000-MY99999999

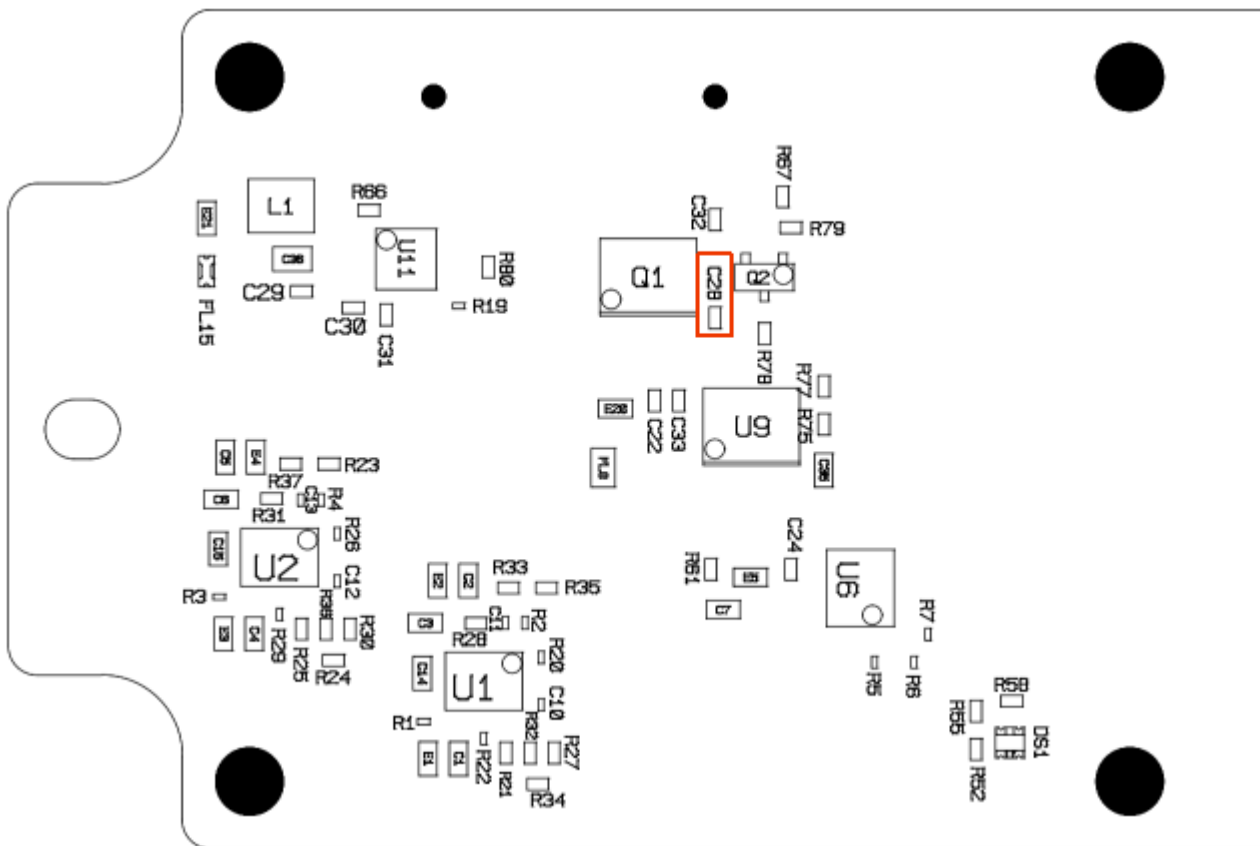
The heater circuit in the N469xD ECal modules was initially designed with a dampening capacitor. It was found in a small number of ECal modules that a resonance can develop in this circuit after the modules is warmed up. This resonance can cause an RF tone between 140 MHz and 150 MHz to be injected onto the signal path.

Open the ECal module and remove the N4690-63004 printed circuit board. On this board, locate the C28 capacitor indicated here:

If this capacitor has been removed, no further action is required. Reassemble the ECal module.

If this capacitor exists on this board, this capacitor should be carefully unsoldered and removed, or the N4690-63004 printed circuit assembly should be replaced. Once this is done, reassemble the ECal module.
