N4902A-01-S

S E R V I C E N O T E

Product Number: N4902A , Serial BERT

POSSIBLE FIRE HAZARD

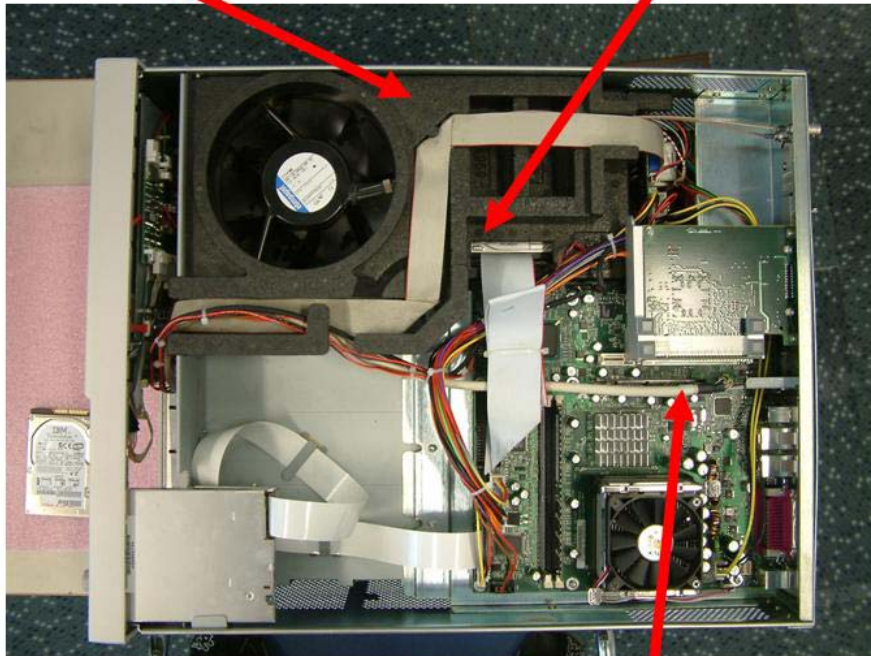
A surface-mount ceramic capacitor suffered physical stress during the manufacturing process, leading the capacitor to crack. During operation this crack placed stress on the internal structure of the capacitor, and caused the plates to short together. (The plates are separated by very little space, made up of very thin insulators.) This caused the capacitor to have very low residual impedance, resulting in a very high current conducted through the capacitor and the 12V path on the motherboard for some period of time. The low impedance didn't lead to a current high enough for blowing the fuse. Therefore the higher current was available long enough to create a very high temperature ($T > 300^{\circ}\text{C}$). The high temperature ignited the polyurethane molding used to conduct the airflow for cooling through the instrument.

The following photo illustrates the layout of the instrument. It shows the polypropylene molding, the graphics card and the starting point of the fire.

Polypropylene Molding

Start of Fire

Graphics Card

The countermeasure for this issue is to exchange the graphics cards. The new graphics cards are produced with an improved manufacturing process eliminating the risk of micro cracks and have additional fusing to protect the 12V path. The graphics card can be exchanged by Agilent authorized personnel only.

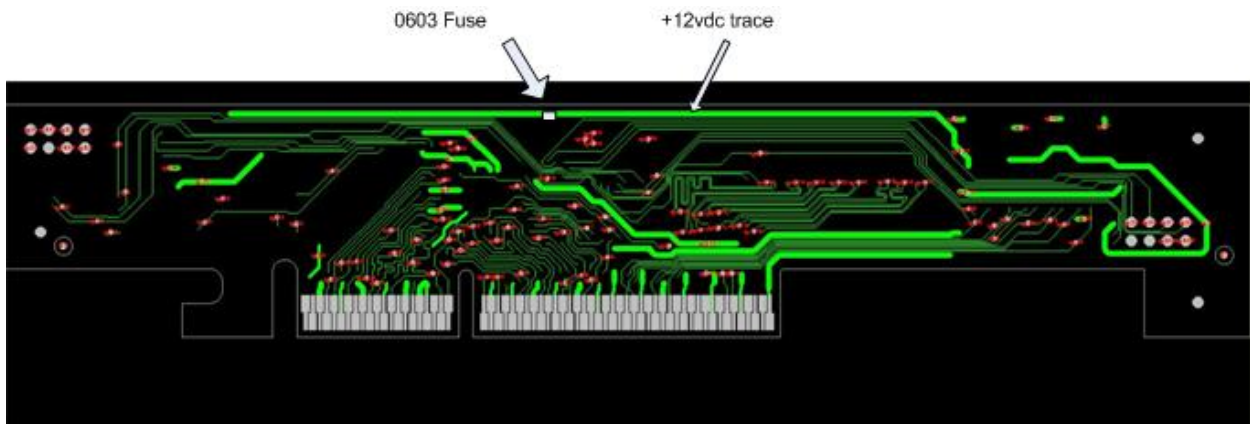
The following picture shows the graphics card with the added fuse:
