N5171B-07A

# Information Only Service Note

## N5171B X-Series EXG Analog Signal Generator

**The Problem** - A3 RF assembly boards showing Heater and Unlock errors

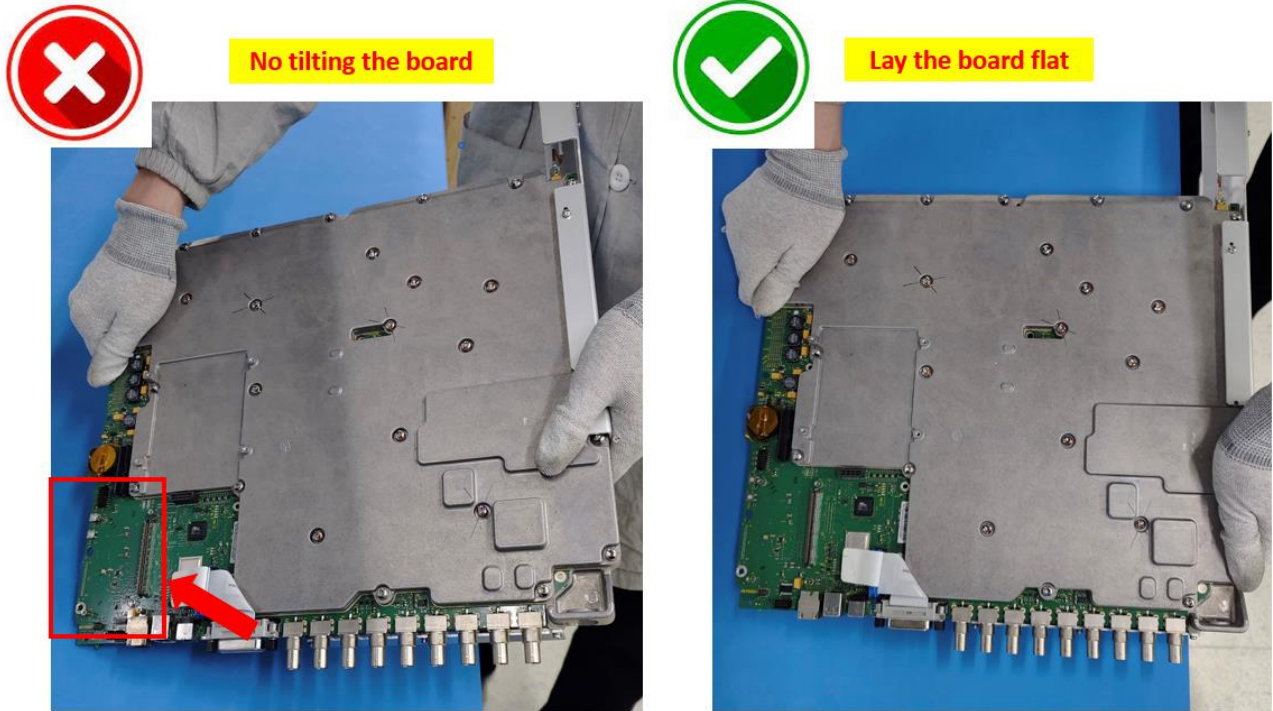
Figure 5

Avoid tilting the board where components touches the workbench. This would give pressure on the PCA and potentially can damaged the PCA as well as the components in the area. Always lay the board flat on the workbench. Refer to Figure 5.

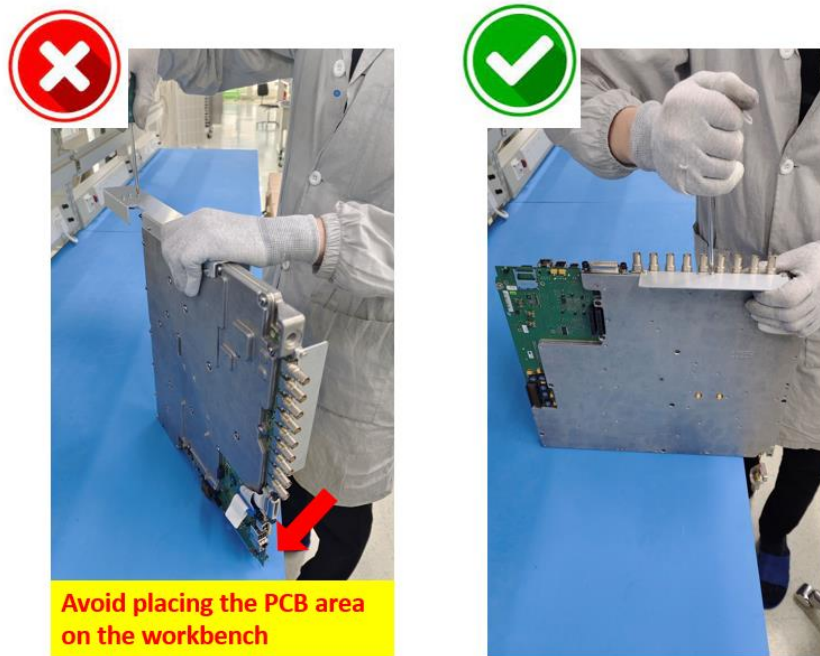
Figure 6 shows the correct and incorrect method of holding the board while removing and fixing the fixture.

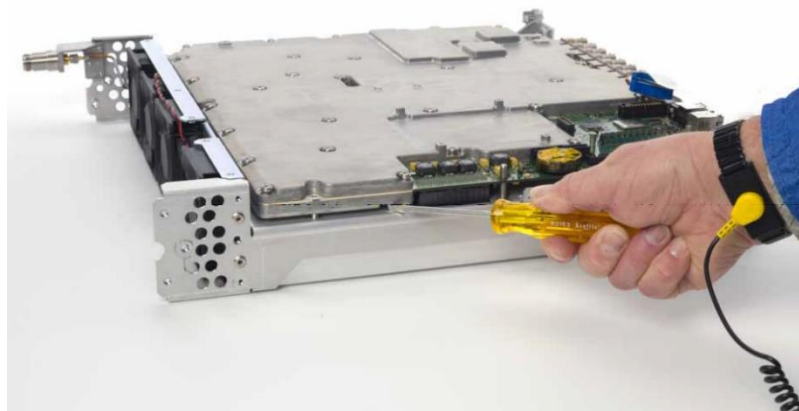
Figure 7

Pry slots are provided on both sides of the A3 RF assembly to aid in removing of the board. Use a flat head (a wedge-shaped flat tip) screwdriver to loosen the board from the chassis as shown in Figure 7.
