N5173B-10A

Information Only Service Note

N5173B X-Series EXG μ Wave Signal Generator

The Problem - A3 RF assembly boards showing Heater and Unlock errors

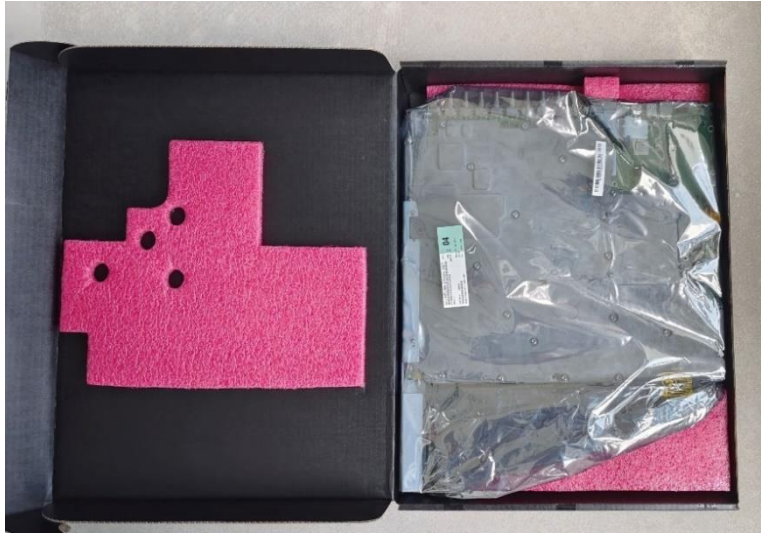
Figure 3

Below figures 3 and 4 shows the correct and incorrect method to remove the A3 RF assembly board from the carton box.

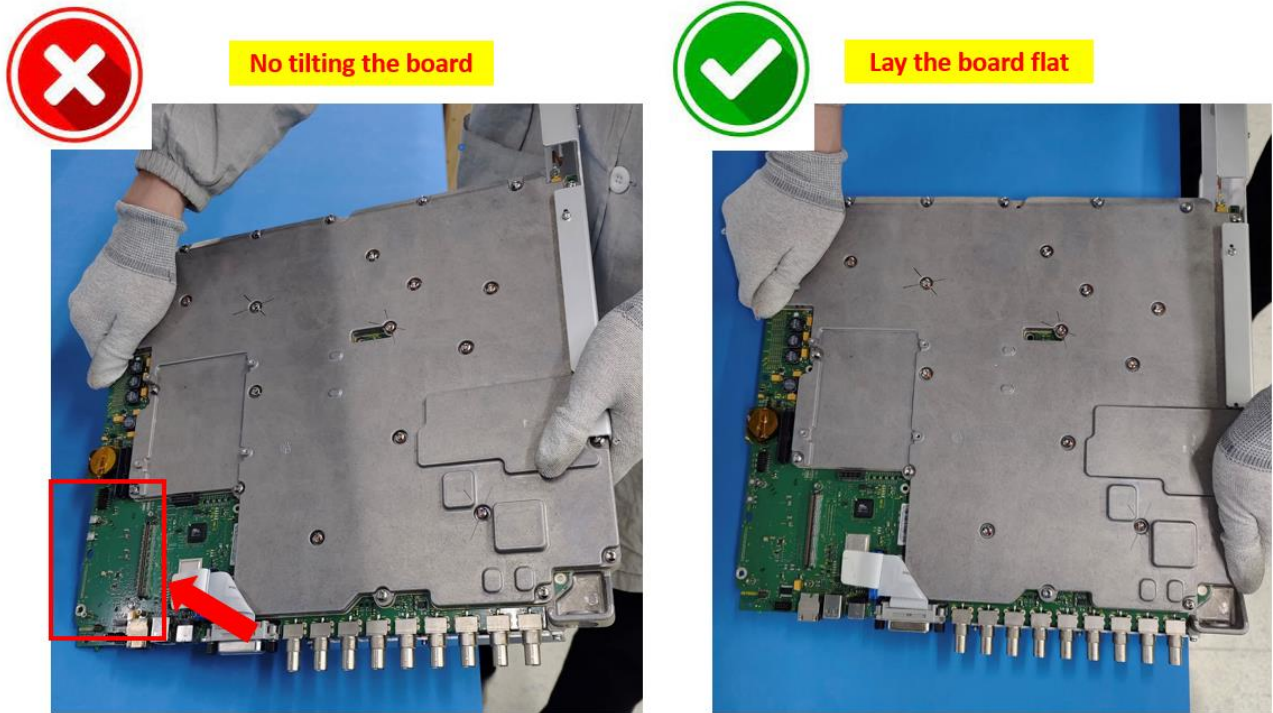
Figure 5

Avoid tilting the board where components touches the workbench. This would give pressure on the PCA and potentially can damaged the PCA as well as the components in the area. Always lay the board flat on the workbench. Refer to Figure 5.

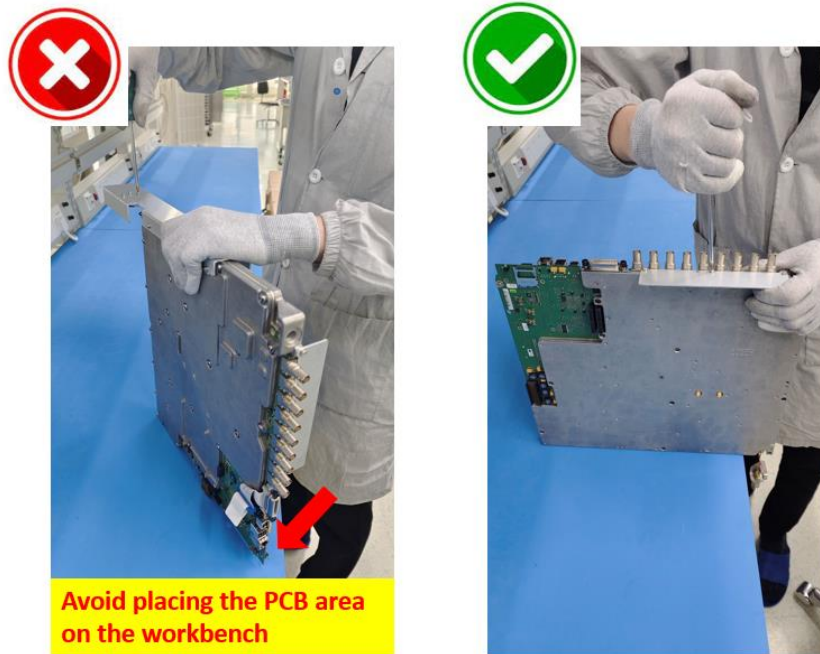
Figure 6 shows the correct and incorrect method of holding the board while removing and fixing the fixture.

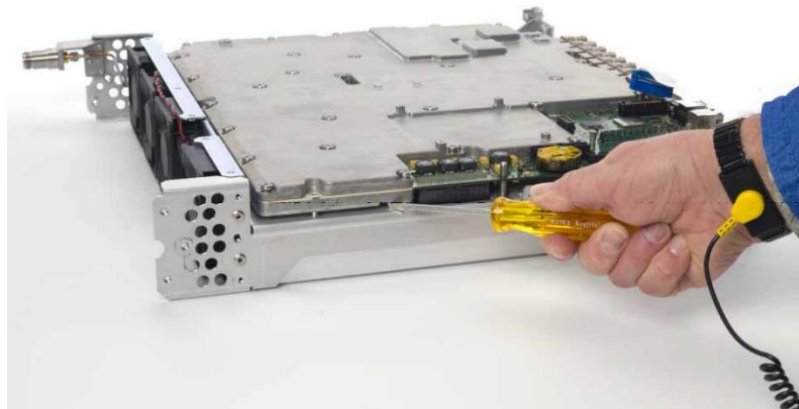
Figure 7

Pry slots are provided on both sides of the A3 RF assembly to aid in removing of the board. Use a flat head (a wedge-shaped flat tip) screwdriver to loosen the board from the chassis as shown in Figure 7.

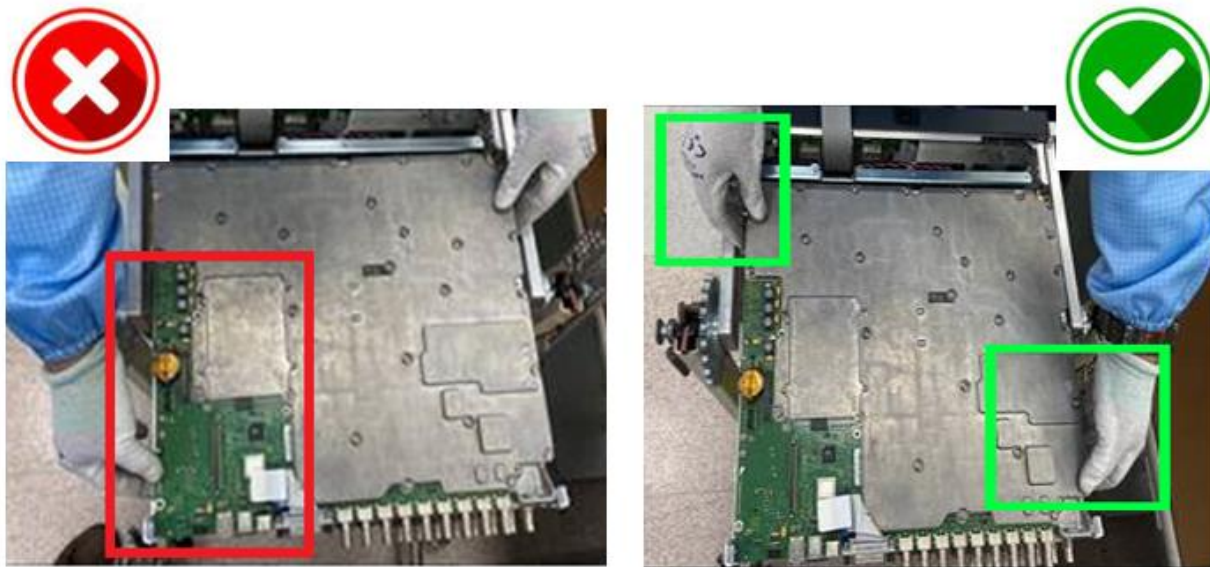
Figure 8 shows the correct and incorrect method of holding the board while removing and installing the board to the instrument.

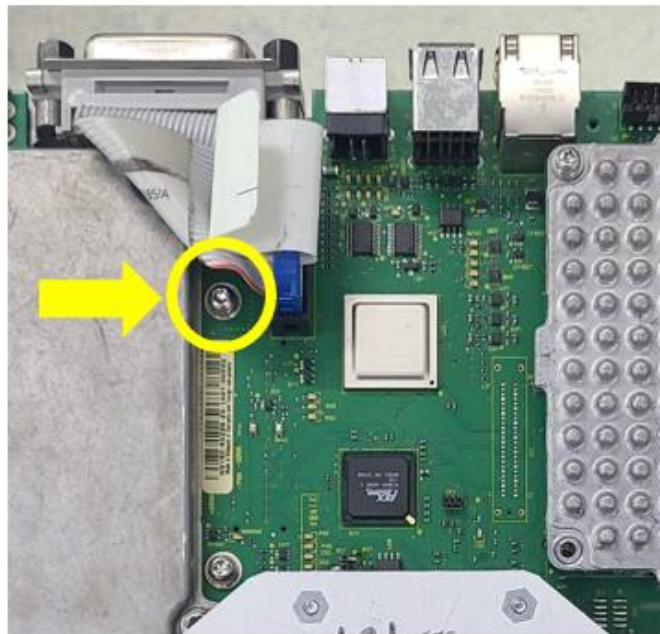
Figure 9

Another precaution is when removing and reinstalling back the screw (refer to Figure 9), it is not necessary to remove the ribbon cable to avoid re-attaching the ribbon cable back.
