**N5182A-05****S E R V I C E      N O T E**

Supersedes:  
None**N5182A MXG Vector Signal Generator**

**Blank (Dark) LCD front panel may be caused by shorted LCD wires.**

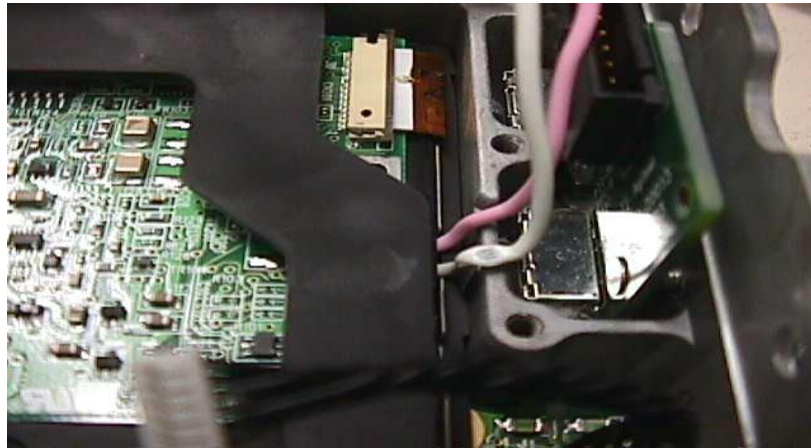
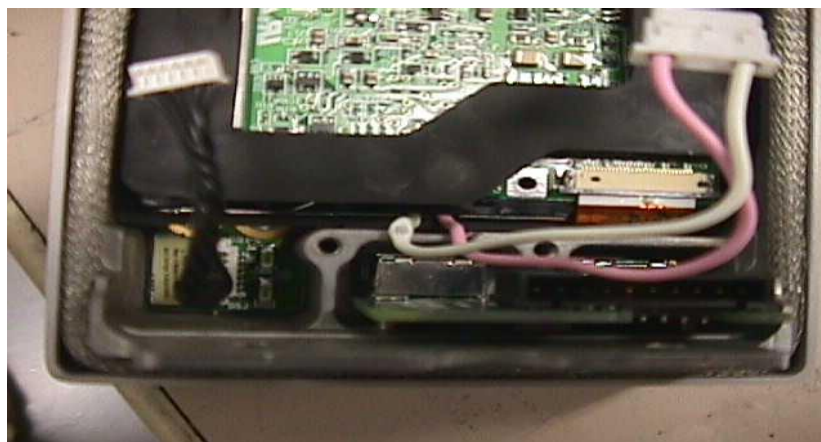
There has been a few random N5182A MXG Signal Generators discovered in the field with pinched Liquid Crystal Display (LCD) power leads. Though this is not a safety concern, the pinched LCD leads may overtime, become shorted resulting in a dark LCD display.

A N5182A MXG Signal Generator that appears to be operating correctly; unit turns-on, fans are functioning and the green power-on switch LED is visible but the front panel LCD screen is dark, may be the result of shorted power leads.

See example images below:

It is suggested that at the time of contact, the LCD leads be inspected for the possibility that the LCD leads are pinched. The LCD leads should move freely as they pass between the sub-panel sheet metal and the front panel casting. When in doubt, remove the front panel sub-panel in accordance with the MXG Service Guide. If the leads are found pinched, but no short has occurred. Reposition the affected lead(s) and if deemed necessary, apply insulating tape to the affected area. Re-assemble the front panel according to the MXG Service Guide ensuring the leads are no longer pinched.

When troubleshooting a MXG with a dark LCD, inspect for the pinched power leads as a possible cause of the dark display. If the leads are found pinched resulting in a physical short, replace the LCD assembly (P/N: N5180-60024) in accordance with the MXG Service Guide.

Additionally, it is recommended when LCD leads are uncovered as being shorted, the front panel Key Pad (P/N: N5180-60021) should also be replaced. While there is no direct empirical proof that the RPG on the Key Pad assembly has been damaged, a connection between shorted LCD lead(s) and the possibility of latent future RPG failures has been made, leading to a proactive desire to replace both assemblies.
