N5230A-01C

S E R V I C E N O T E

N5230A PNA Series RF Network Analyzers

Serial Numbers: 00000000 thru 46999999

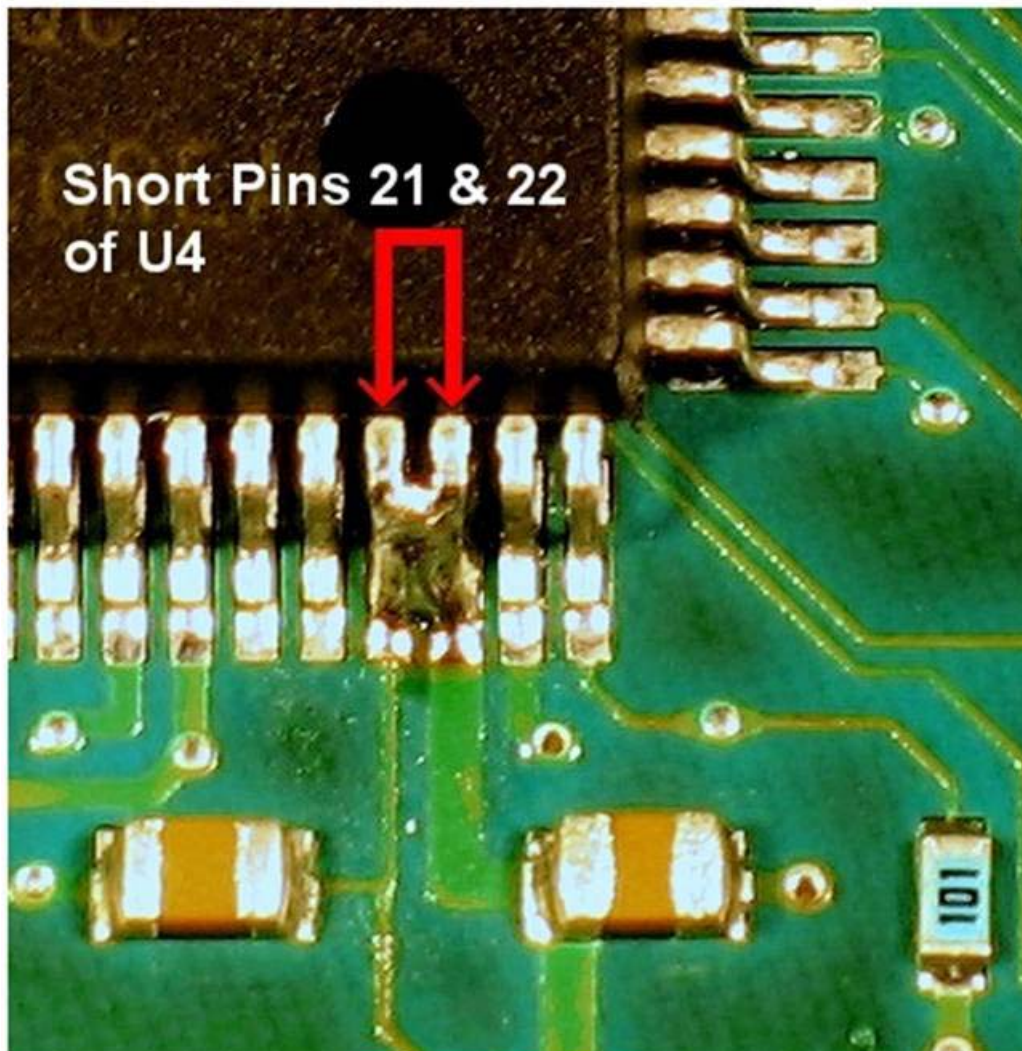
Both intermittent problems have been traced to an incorrect voltage applied to a pin on the U4 IC.

Carefully solder pins 21 and 22 together on U4. Refer to Figure 2 for the exact location. Use care so that no other pins are shorted. Use of a very fine tip soldering iron is recommended and a large work-task magnifying glass is very helpful.
