N5230A-03A

S E R V I C E N O T E

N5230A PNA Microwave Network Analyzers

Serial Numbers: US00000000/US99999999 and MY00000000/MY00000000 [All]

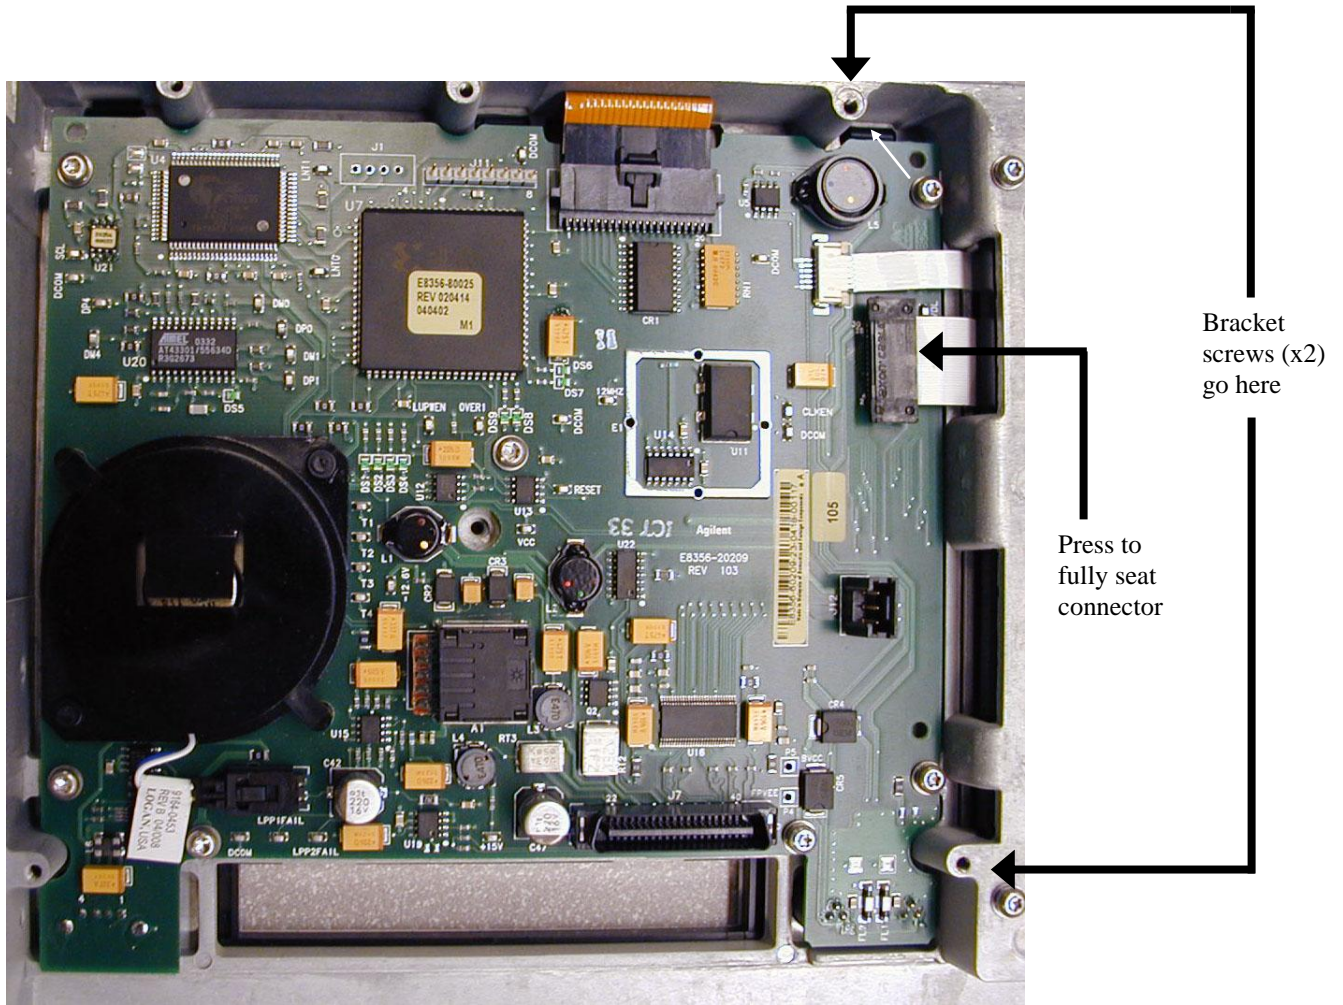
A connector of the ribbon cable (Agilent part number 8120-8409) that joins the front panel display to the front panel interface board can loosen, causing a display failure, unless a new bracket is installed. Because the failure rate has been very low, it is recommended that the bracket be installed only when there is an additional reason to remove the PNA front panel.

Figure 1: A3 Front Panel Interface Board Assy without the Bracket

1. Refer to Figure 1 in this document:
 - Press down firmly on the ribbon cable's black connector.
 - Locate the two tapped holes for the bracket screws.
2. As shown in Figure 2 in this document, position the bracket so that its holes line-up with the two holes you located in the previous step.
3. Hand-start the two screws, and then torque both to 9 in-lbs.
4. Reinstall the PNA Front Panel by following the Service Guide instructions in the "Replacement Procedure." This is located on the same page as the "Removal Procedure" used previously in step 7.

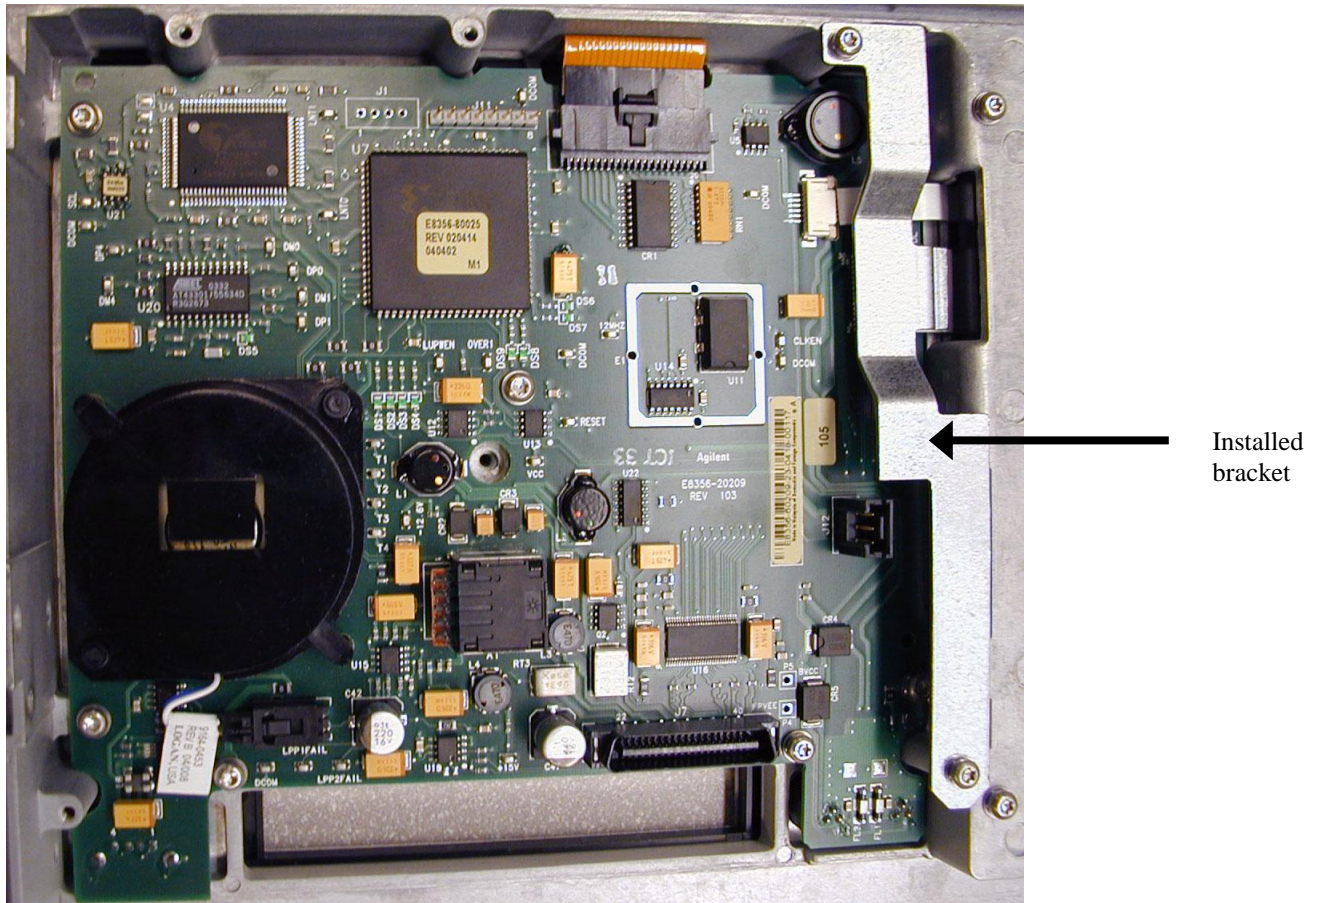
Figure 2: A3 Front Panel Interface Board Assy with the Bracket Installed
