**N5230A-05****S E R V I C E N O T E**Supersedes:  
NONE**N5230A PNA Series RF Network Analyzers****Serial Numbers: 0000A00000/9999Z99999 [All]****Replace Inverter board (0950-3379) due to faulty component.****To Be Performed By: Agilent-qualified personnel or customer with  
specific product repair knowledge - requires  
instrument disassembly and component replacement.****Parts Required:**

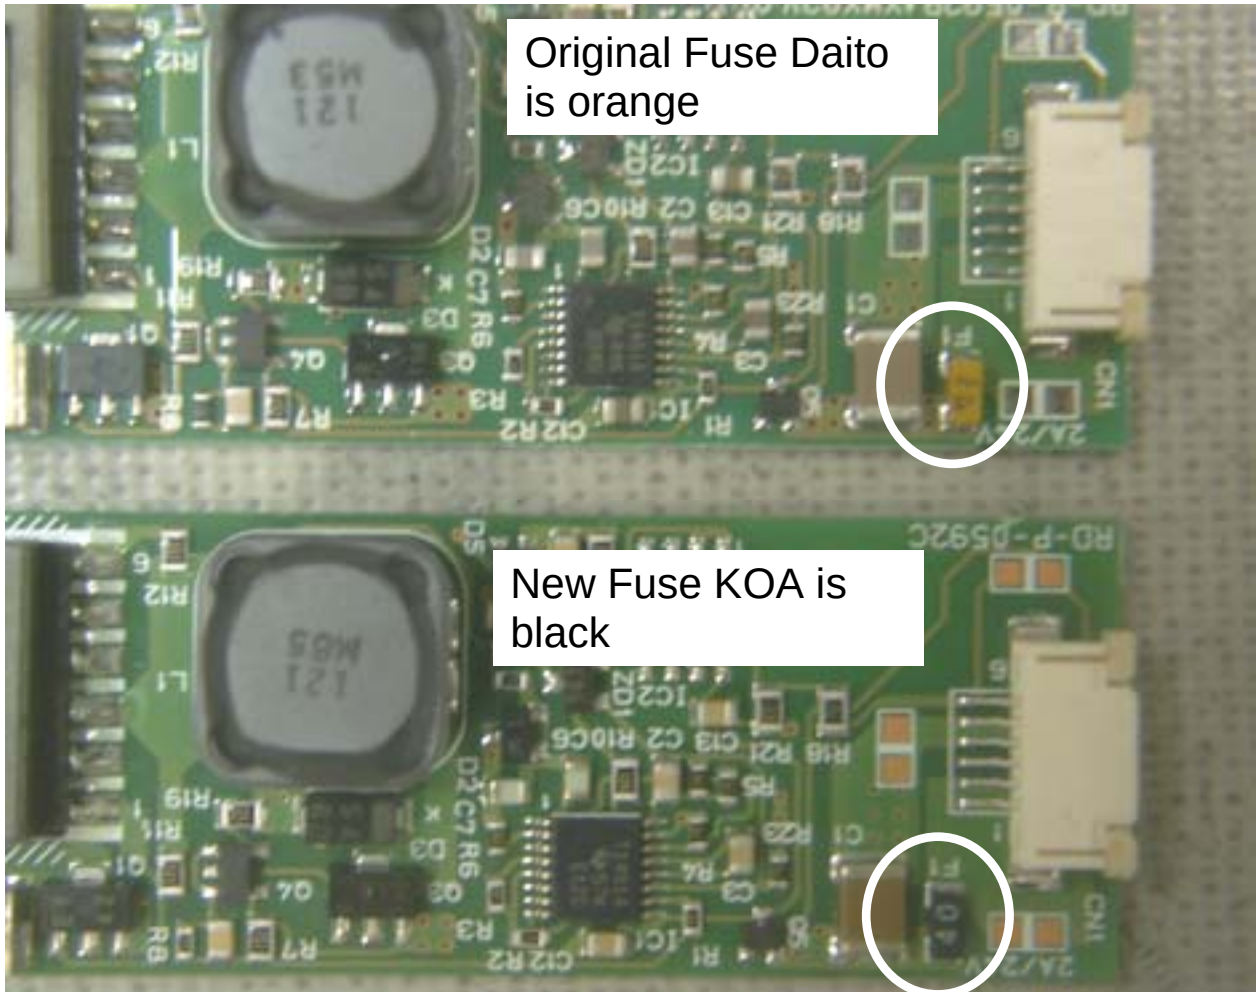
The original fuse (see photo) in the DC/AC Inverter board (p/n 0950-3379) is prone to failure in normal use.

Replace the Inverter board with a board containing the new fuse (see photo).
