**N5230C-03**

**S E R V I C E N O T E**

**PNA Series Network Analyzer Hard Drive Tray Modification**

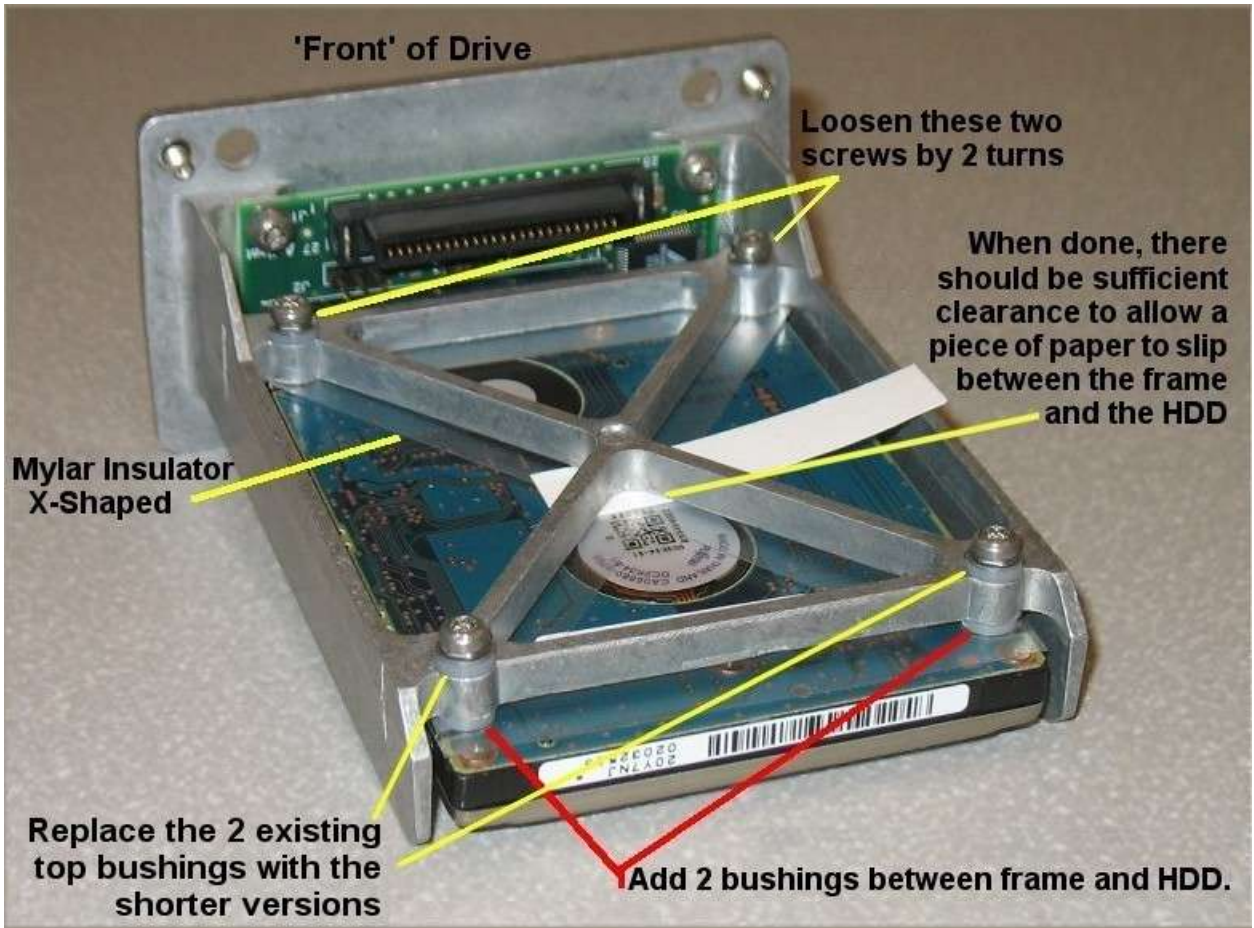
It is possible that the center of the X-frame of the HDD tray is slightly bowed which will cause the hard drive to warp when secured with screws. If warped, a head crash may occur that can destroy the drive. Only SATA (Serial ATA) drives are affected - PATA drives don't have this issue. SATA drives are identifiable by a flat, X-shaped Mylar insulator between the drive and the tray - see the photo. Also affected are trays used for replacement/swapping purposes on the E836xA/B and N5230A models. This issue does not affect the PNA-X series.

The mounting of the tray must be modified so that there is *some* clearance between the HDD and the center of the tray frame. This is accomplished by adding two bottom bushings to the rear of the drive, between the drive and the tray. The existing top bushings must be replaced because they are too long to accommodate the additional bottom ones. A total of four new bushings are used in this rework.

2. Remove the two screws and the bushings underneath them at the rear of the drive. Discard the bushings.
3. Add two new bushings between the metal frame and the HDD, but above the Mylar X insulator. Make sure to use the holes closest to the rear edge of the frame.

4. Install a new bushing on both screws that were removed in step 2. These new bushings are shorter than the original ones.
5. Reinstall the two screws and their new bushings at the rear of the drive, then torque the screws to 0.8 N-m (7 in-lbs).

6. Tighten the two screws near the front of the drive to the same torque value above.
7. Verify that there is now *some* clearance at the center of the X-frame by slipping a piece of paper between the drive and the frame as shown in the picture below.
