N5540A-01-S

S E R V I C E N O T E

N2X (Router Tester 900) Chassis

Potential power supply failure due to component lead length.

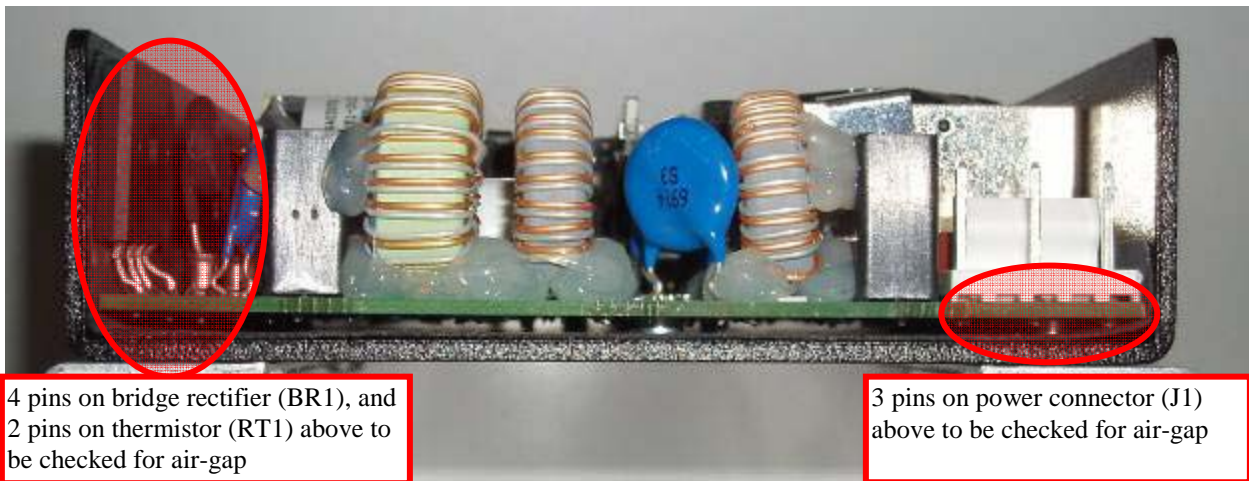
Analysis showed that some through-hole components did not have their leads trimmed to the proper length (they were too long), and as a result of vibration testing done after OEM HiPot tests, or shock/vibration in transit, the extended leads were piercing the insulation barrier between the mains powered components, and the PSU metalwork.

Check the power supply through-hole components as shown below to ensure that there is an air gap between the component leads highlighted and the insulation situated between the metalwork and PCB.

If there is an air-gap, the power supply can be re-fitted to the chassis and returned to the customer after being tested in accordance with the procedures outlined in the above mentioned service manual.

If there is *not* an air gap, then the power supply should be replaced by a new one – part number E7900-64800 – and the defective one should be returned to SPO for credit return to the division manufacturing organisation.
