N5541A-01-S

S E R V I C E N O T E

N2X (Router Tester 900) Chassis

Potential power supply failure due to component lead length.

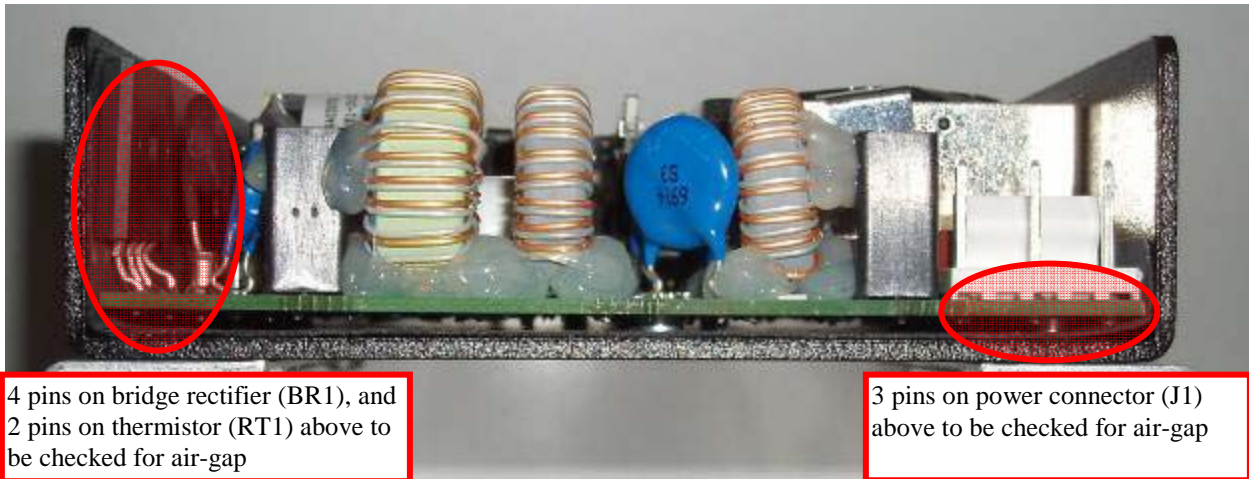
Analysis showed that some through-hole components did not have their leads trimmed to the proper length (they were too long), and as a result of vibration testing done after OEM HiPot tests, or shock/vibration in transit, the extended leads were piercing the insulation barrier between the mains powered components, and the PSU metalwork.

Check the power supply through-hole components as shown below to ensure that there is an air gap between the component leads highlighted and the insulation situated between the metalwork and PCB.

4 pins on bridge rectifier (BR1), and 2 pins on thermistor (RT1) above to be checked for air-gap

3 pins on power connector (J1) above to be checked for air-gap

If there is an air-gap, the power supply can be re-fitted to the chassis and returned to the customer after being tested in accordance with the procedures outlined in the above mentioned service manual.

If there is *not* an air gap, then the power supply should be replaced by a new one – part number E7900-64800 – and the defective one should be returned to SPO for credit return to the division manufacturing organisation.
