N5542A-01-S

S E R V I C E N O T E

N2X (Router Tester 900) Chassis

Potential power supply failure due to component lead length.

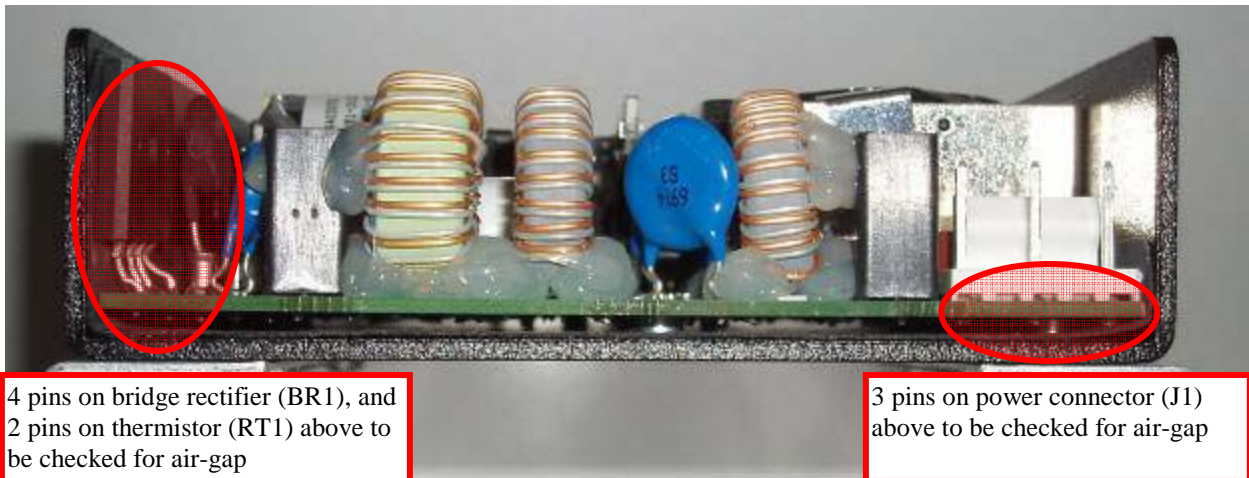
Analysis showed that some through-hole components did not have their leads trimmed to the proper length (they were too long), and as a result of vibration testing done after OEM HiPot tests, or shock/vibration in transit, the extended leads were piercing the insulation barrier between the mains powered components, and the PSU metalwork.

Check the power supply through-hole components as shown below to ensure that there is an air gap between the component leads highlighted and the insulation situated between the metalwork and PCB.

4 pins on bridge rectifier (BR1), and 2 pins on thermistor (RT1) above to be checked for air-gap

3 pins on power connector (J1) above to be checked for air-gap

If there is an air-gap, the power supply can be re-fitted to the chassis and returned to the customer after being tested in accordance with the procedures outlined in the above mentioned service manual.

If there is *not* an air gap, then the power supply should be replaced by a new one – part number E7900-64800 – and the defective one should be returned to SPO for credit return to the division manufacturing organisation.
