**N6762A-02**

**S E R V I C E N O T E**

**N6762A Precision DC Power Module**

**Firmware update will address an issue where N6700A, N6700B, N6701A and N6702A mainframes will not detect the 2UA Option during a query for the option information from the mainframe's menu as well as using the SCPI command SYST:CHAN:OPT? (@<chanlist>).**

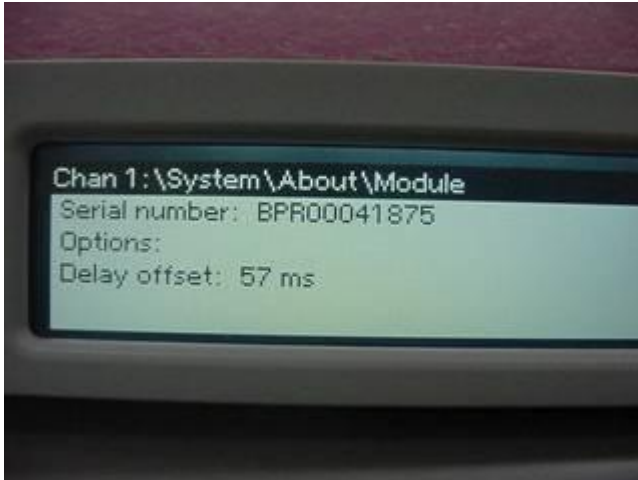
All N6700A, N6700B, N6701A and N6702A mainframes with a firmware revision lower than C.02.18 have the potential to not detect the 2UA Option during a query for the option information from the mainframe's menu as well as using the SCPI command SYST:CHAN:OPT? (@<chanlist>).

**Figure 1.** Mainframe is unable to detect Option 2UA

If the firmware revision is older than C.02.18 then the firmware must be upgraded. All files, programs, and instructions required to upgrade the firmware are located at the following website:
