# Modification Recommended Service Note

## N8925A - Autoranging System DC Power Supply, 80V, 340A, 10000W, 208 VAC

Serial Numbers: DE14290000 - DE15369999 without manufacturing ID Version "B"

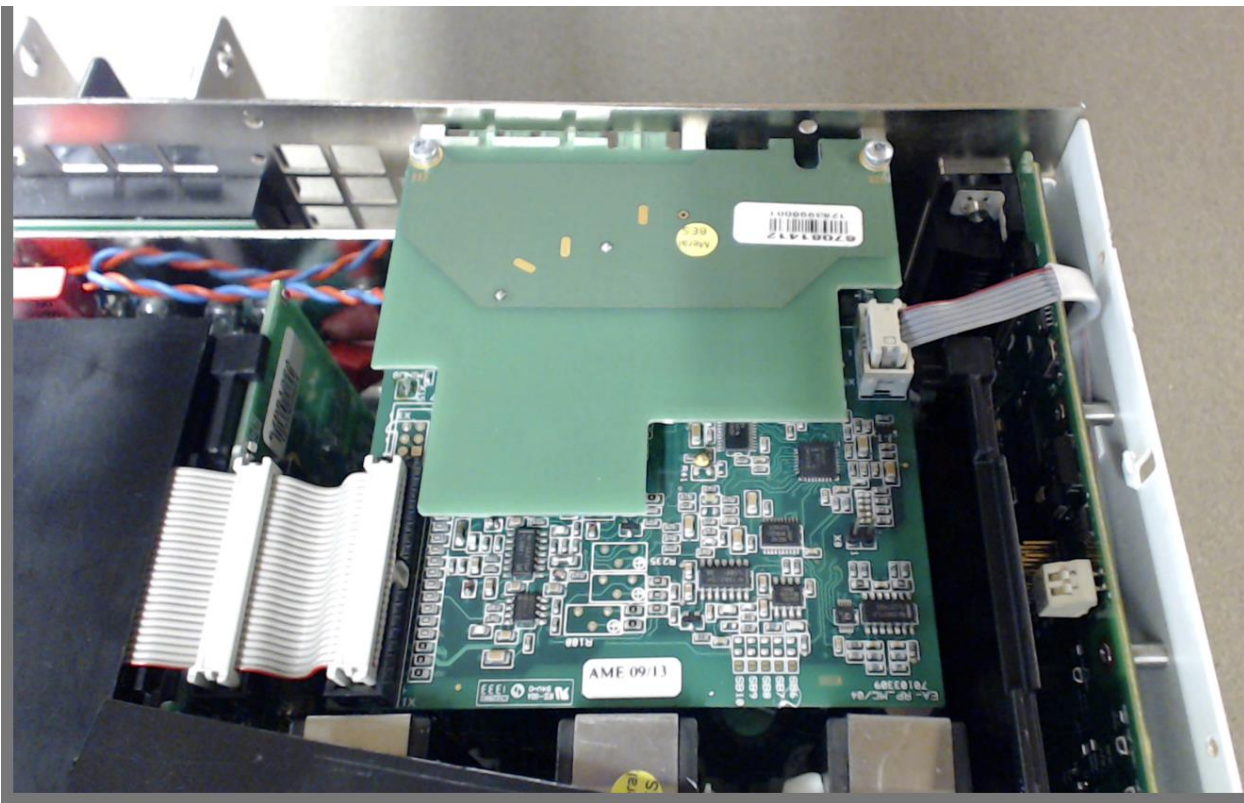
- 1) Remove acMains cable from power source.
- 2) Wait 5 minutes
- 3) Remove top cover from instrument.
- 4) In the 5kW units (viewed from the front of the unit), a small SMT assembly located at the right-rear of instrument will be readily visible (see below):

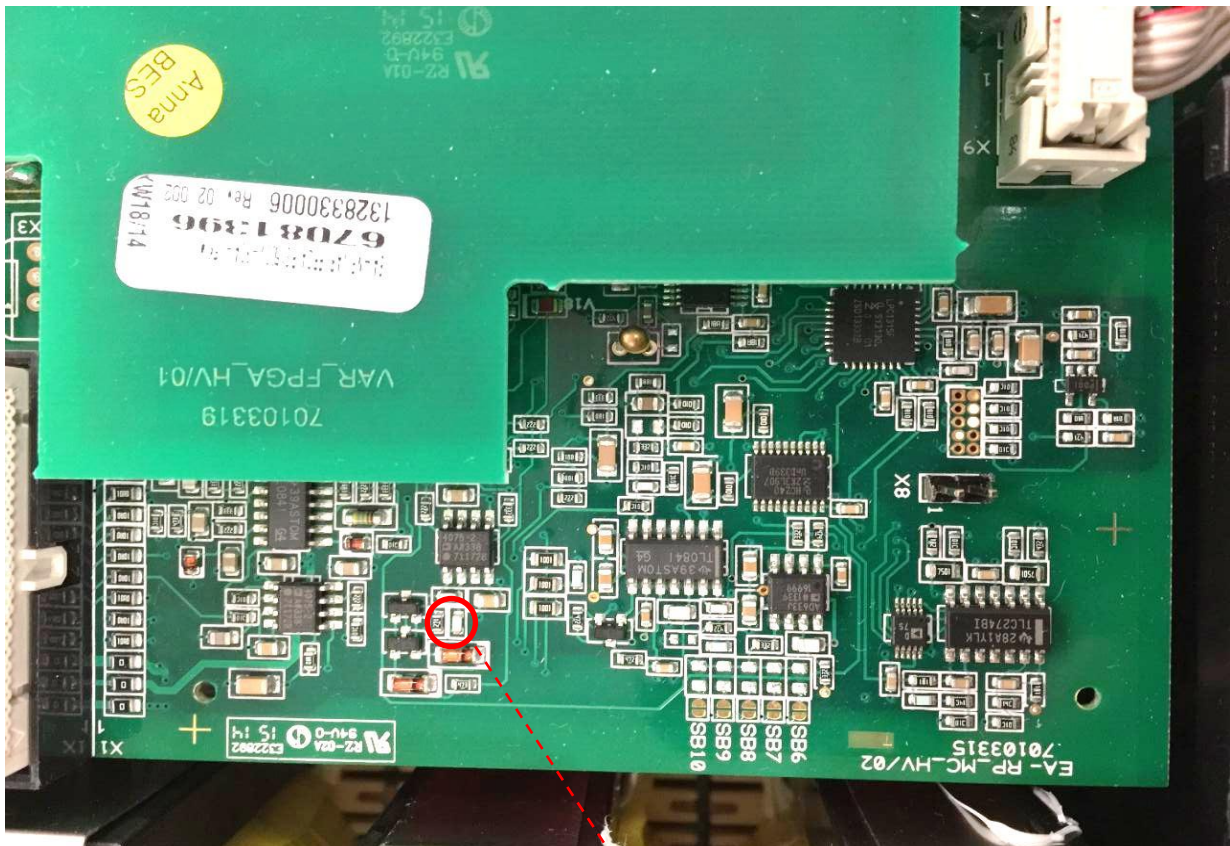
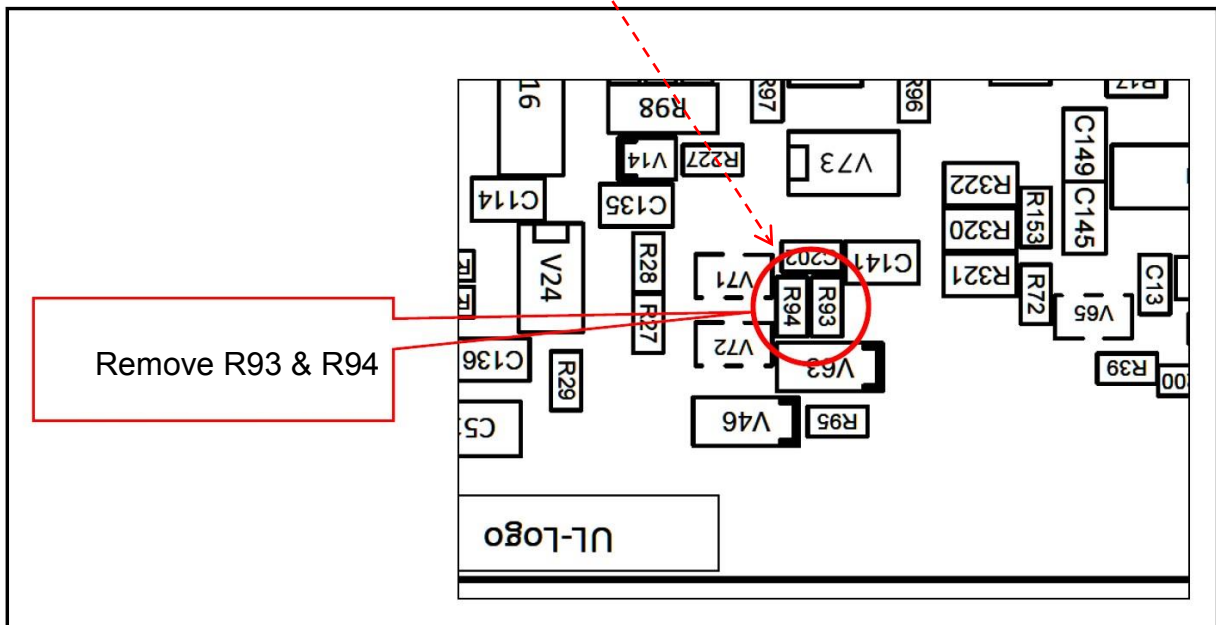
5) SMT resistors R93/94 are located in red circle shown below:

Removal of two (2) surface mount resistors, R93 and R94, will correct this problem:

6) After removal of R93 & R94, re-install all covers. Instrument does NOT require recalibration after the removal of R93 & R94.
