Modification Recommended Service Note

N8934A - Autoranging System DC Power Supply, 500V, 90A, 15000W, 208 VAC

Serial Numbers: DE14290000 - DE15369999 without manufacturing ID Version "B"

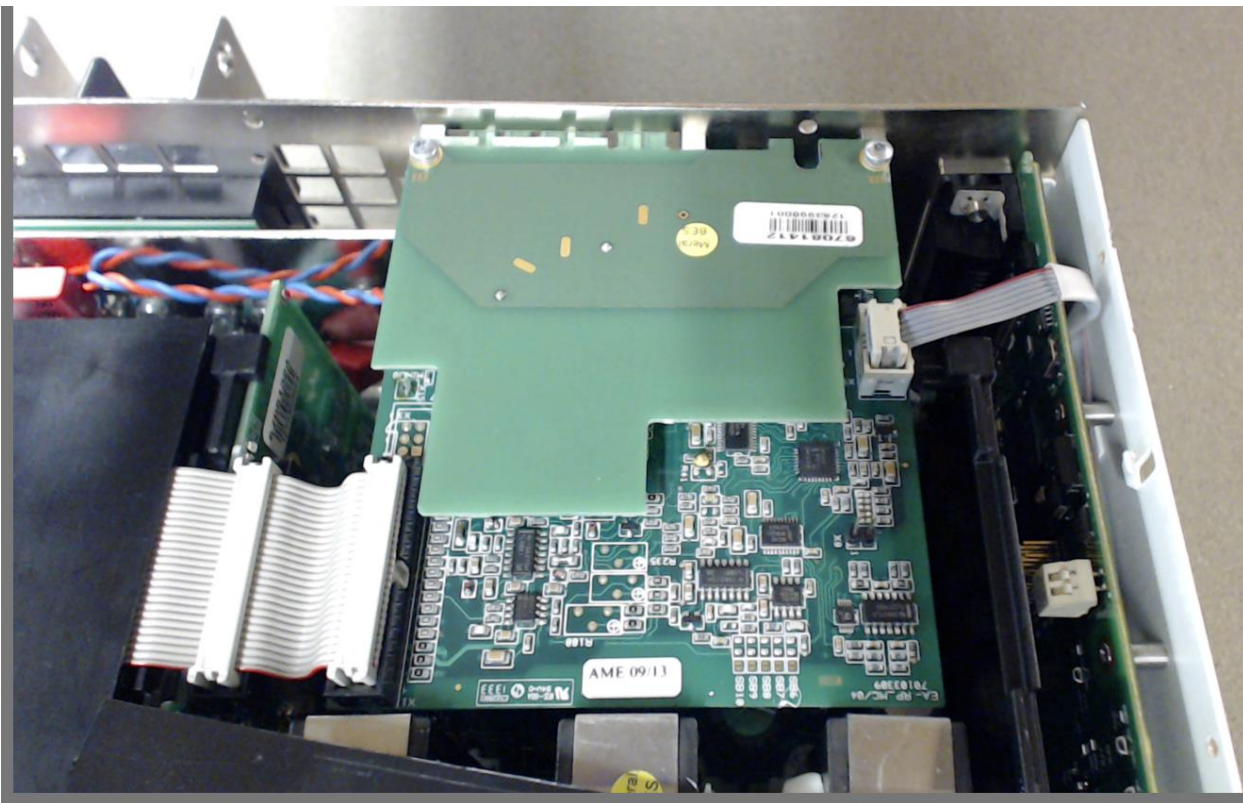
- 1) Remove acMains cable from power source.
- 2) Wait 5 minutes
- 3) Remove top cover from instrument.
- 4) In the 5kW units (viewed from the front of the unit), a small SMT assembly located at the right-rear of instrument will be readily visible (see below):

Removal of two (2) surface mount resistors, R93 and R94, will correct this problem:

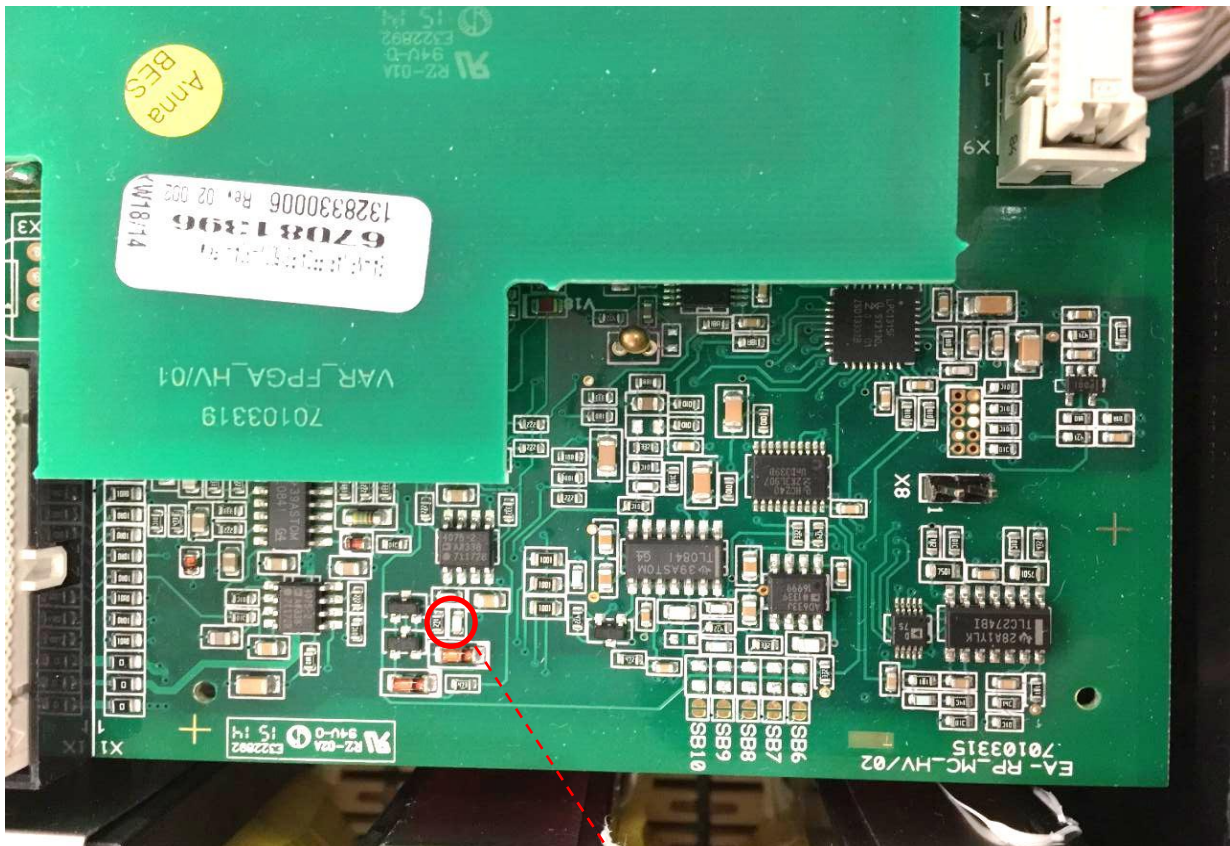
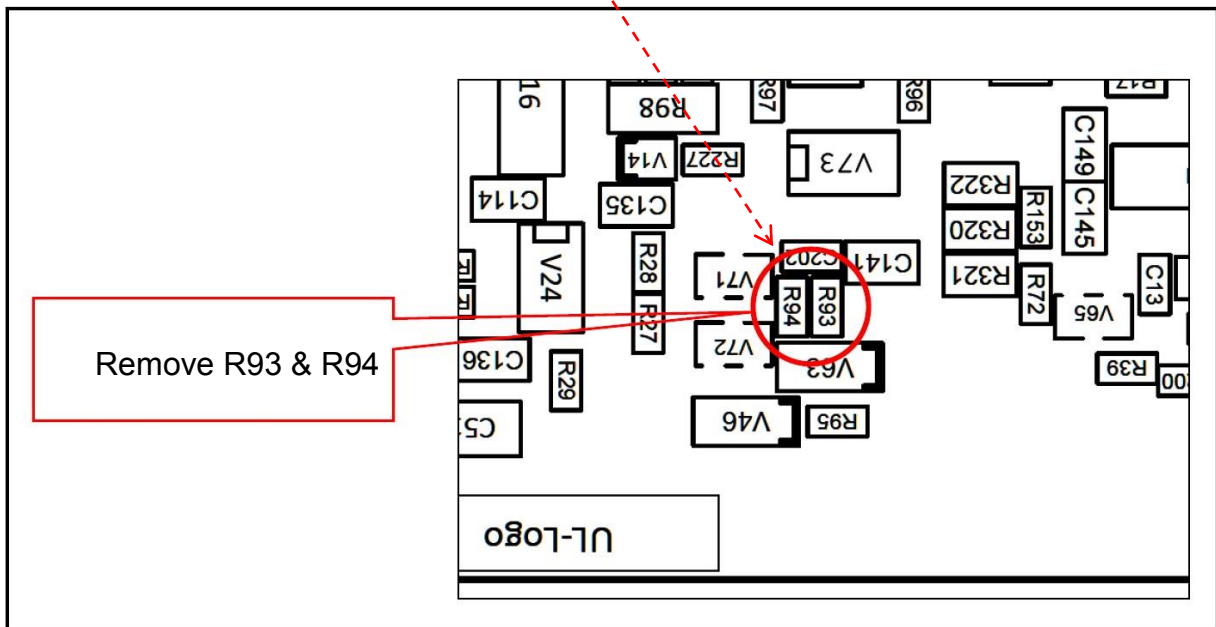
5) SMT resistors R93/94 are located in red circle shown below:

6) After removal of R93 & R94, re-install all covers. Instrument does NOT require recalibration after the removal of R93 & R94.

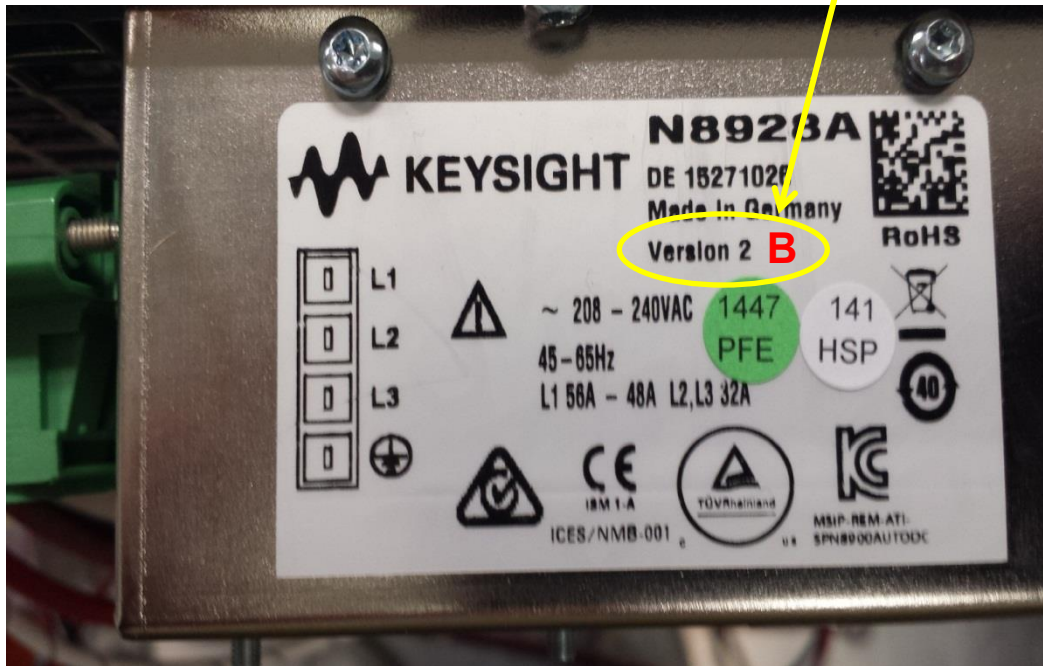
Suffix “B” added

7) On the acMains label, on the rear of the instrument; use an indelible marker, to add the suffix letter “B” after the Version ID. This will assist in the tracking of modified instruments.
