N8937A-02

# Modification Recommended Service Note

## N8937A Autoranging System DC Power Supply

Serial Numbers: DE22350000 to DE23089999

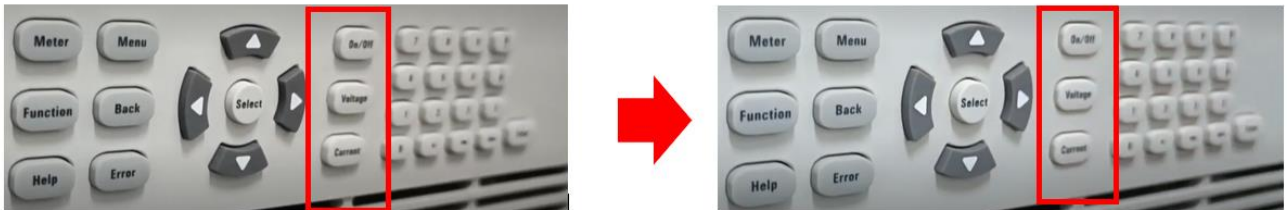
Figure 1: Stuck Keypad

Unit in the above serial number range may intermittently encounter keypad stuck when pressing the keys at front panel. Figure 1 shows an example of a stuck keypad, which could occur with any of the keys.

However, there is no impact on the product performance.

Kindly contact Keysight Technologies Customer Contact Center at [www.keysight.com/find/contactus](http://www.keysight.com/find/contactus) for sending the affected unit back.
