Modification Recommended Service Note

N8943A - Autoranging System DC Power Supply, 500V, 30A, 5000W, 400 VAC

Serial Numbers: DE14290000 - DE15369999 without manufacturing ID Version "B"

The Problem:

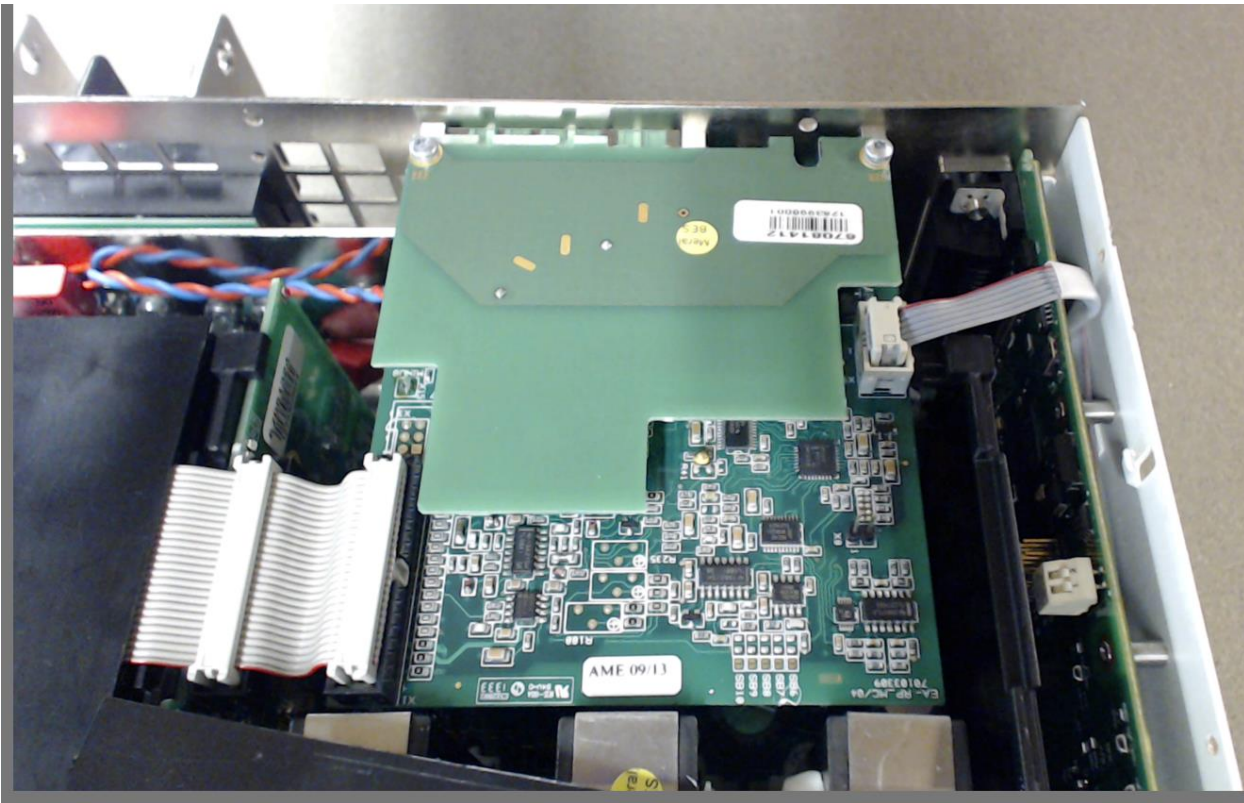
- 1) Remove acMains cable from power source.
- 2) Wait 5 minutes
- 3) Remove top cover from instrument.
- 4) In the 5kW units (viewed from the front of the unit), a small SMT assembly located at the right-rear of instrument will be readily visible (see below):

Removal of two (2) surface mount resistors, R93 and R94, will correct this problem:

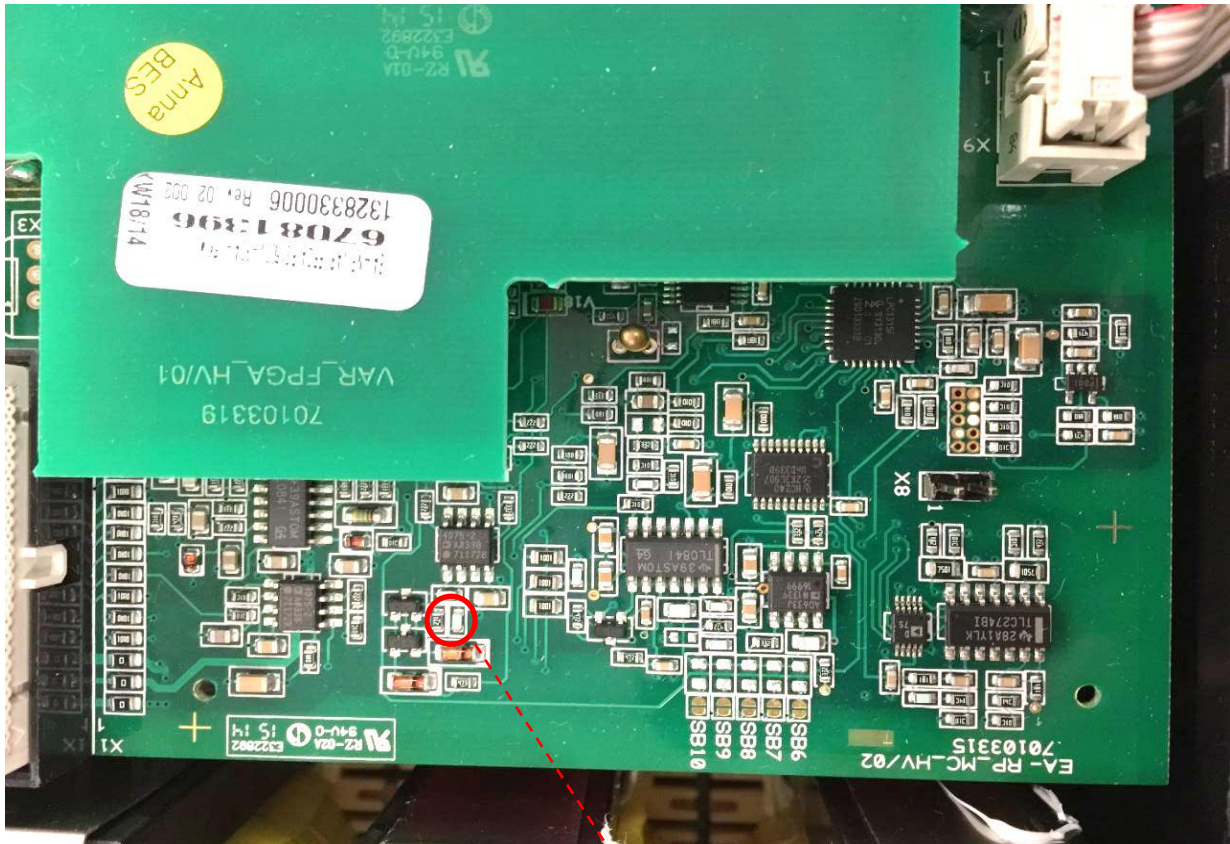
5) SMT resistors R93/94 are located in red circle shown below:

6) After removal of R93 & R94, re-install all covers. Instrument does NOT require recalibration after the removal of R93 & R94.
