N8946A-02

# Modification Recommended Service Note

## N8946A Autoranging System DC Power Supply

Serial Numbers: DE22350000 to DE23089999

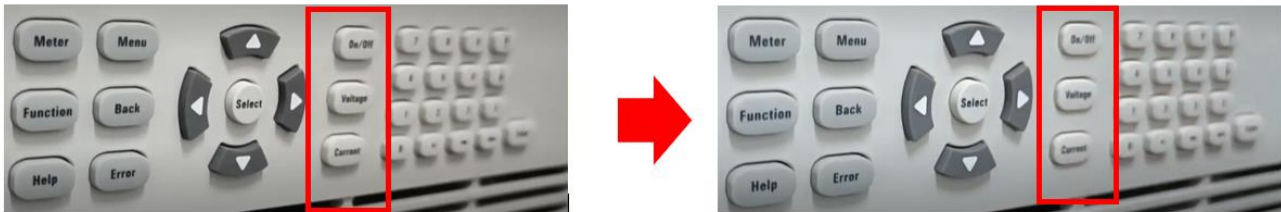
Figure 1: Stuck Keypad

Unit in the above serial number range may intermittently encounter keypad stuck when pressing the keys at front panel. Figure 1 shows an example of a stuck keypad, which could occur with any of the keys.

However, there is no impact on the product performance.

Kindly contact Keysight Technologies Customer Contact Center at [www.keysight.com/find/contactus](http://www.keysight.com/find/contactus) for sending the affected unit back.
