Modification Recommended Service Note

N8949A - Autoranging System DC Power Supply, 750V, 40A, 10000W, 400 VAC

Serial Numbers: DE14290000 - DE15369999 without manufacturing ID Version "B"

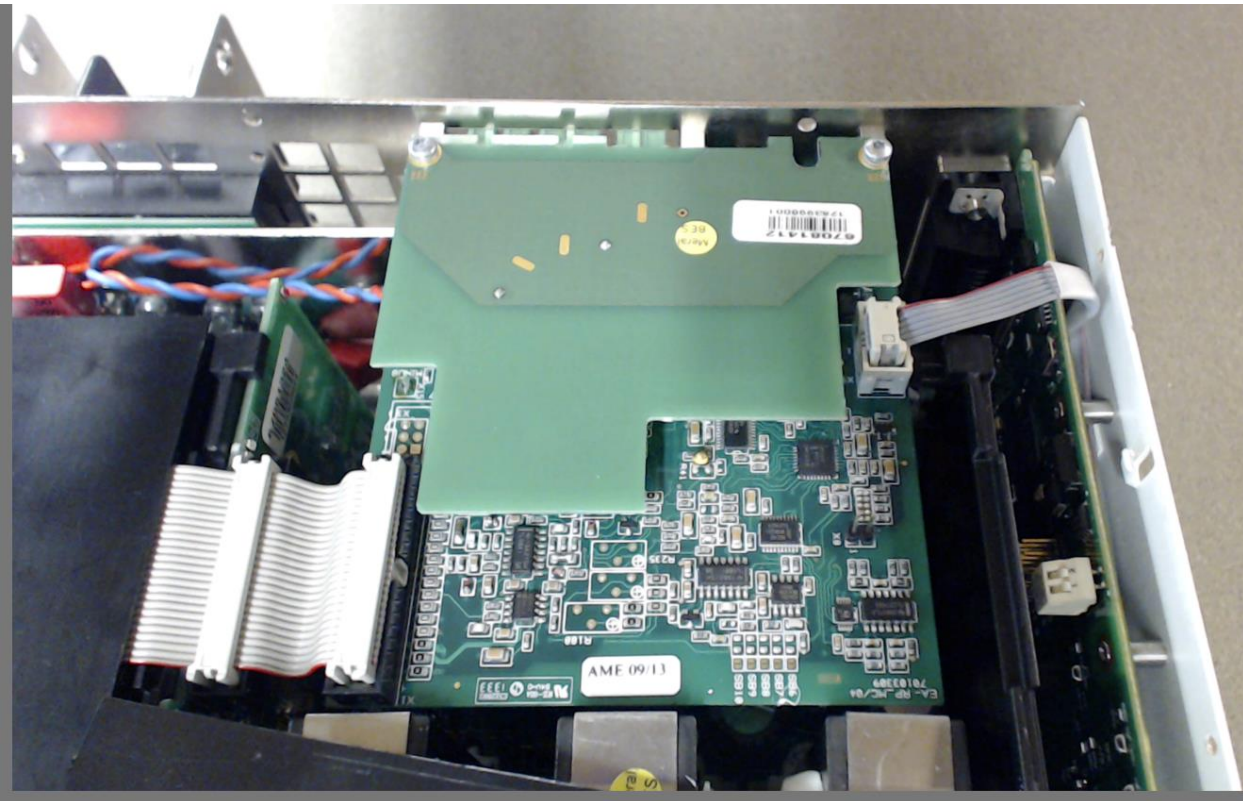
Operation of like model numbered products, in a Master/Slave current sharing configuration could result in a non-uniform distribution of the total output current amongst the configured units. Disparate current division may also cause individual instruments to oscillate.

- 1) Remove acMains cable from power source.
- 2) Wait 5 minutes
- 3) Remove top cover from instrument.
- 4) In the 5kW units (viewed from the front of the unit), a small SMT assembly located at the right-rear of instrument will be readily visible (see below):

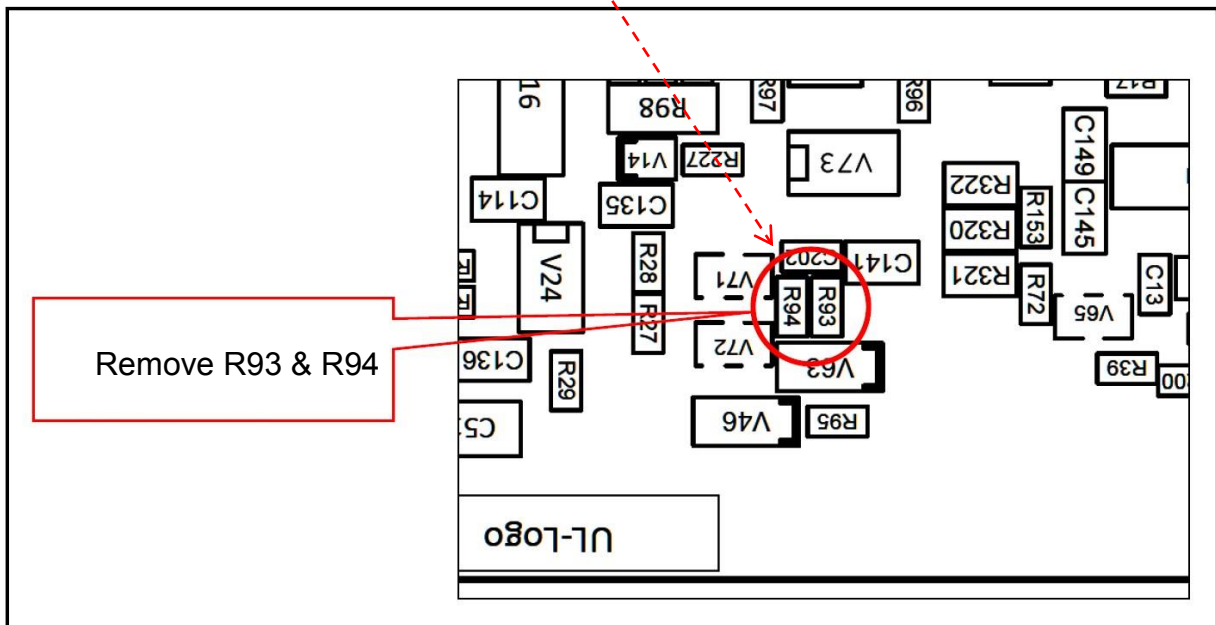
5) SMT resistors R93/94 are located in red circle shown below:

Removal of two (2) surface mount resistors, R93 and R94, will correct this problem:

6) After removal of R93 & R94, re-install all covers. Instrument does NOT require recalibration after the removal of R93 & R94.
