N8950A-02

Modification Recommended Service Note

N8950A Autoranging System DC Power Supply

Serial Numbers: DE22350000 to DE23089999

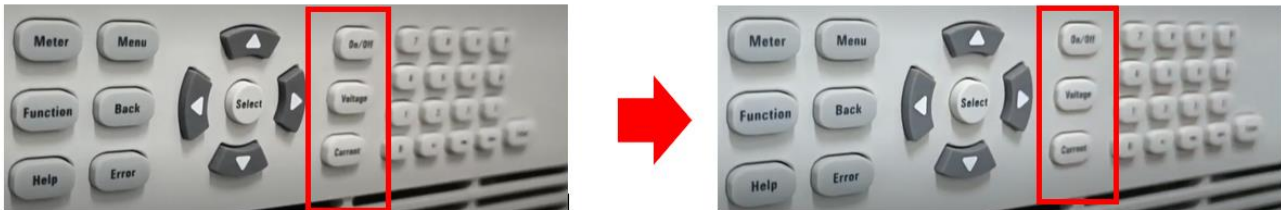
Figure 1: Stuck Keypad

Unit in the above serial number range may intermittently encounter keypad stuck when pressing the keys at front panel. Figure 1 shows an example of a stuck keypad, which could occur with any of the keys.

However, there is no impact on the product performance.

Please send to service center for keypad replacement. Kindly contact Keysight Technologies Customer Contact Center at www.keysight.com/find/contactus for sending the affected unit back.
