Modification Recommended Service Note

N8957A - Autoranging System DC Power Supply, 1500V, 30A, 15000W, 400 VAC

Serial Numbers: DE14290000 - DE15369999 without manufacturing ID Version "B"

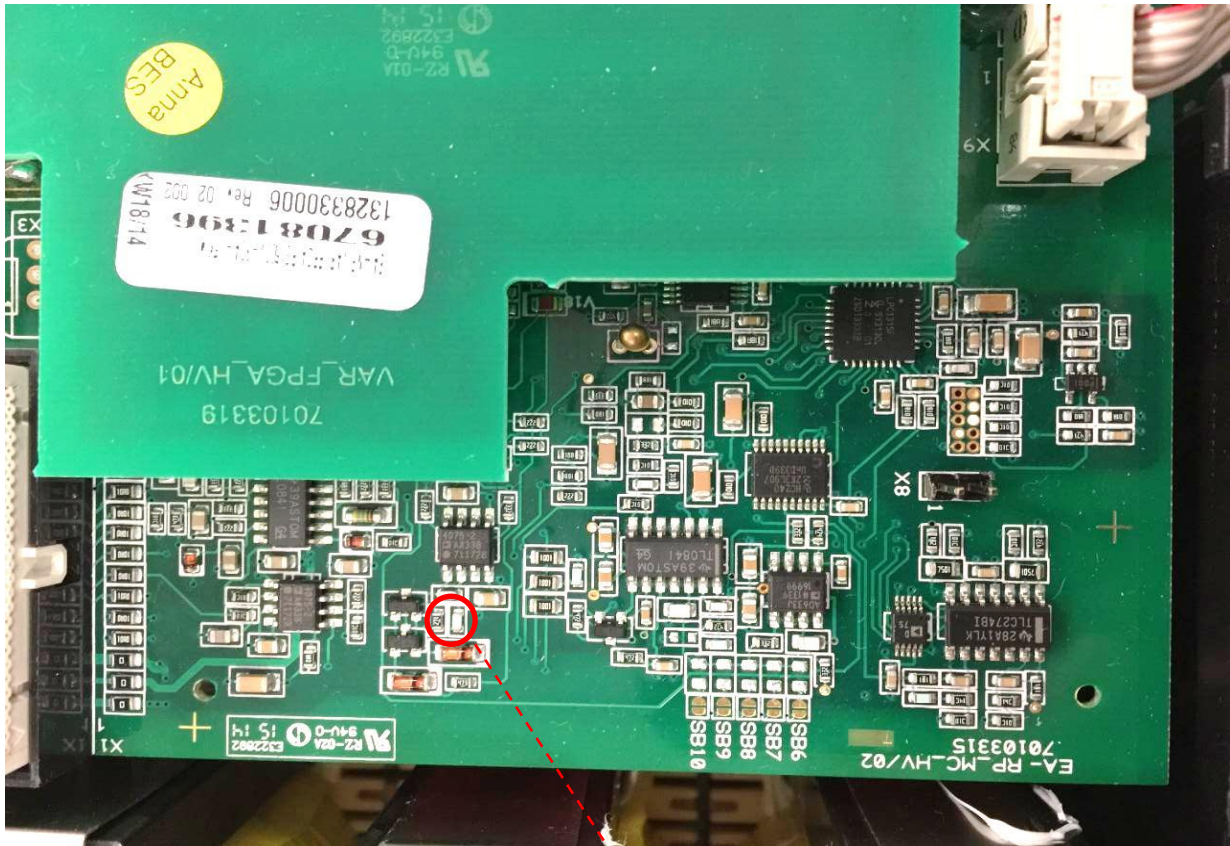
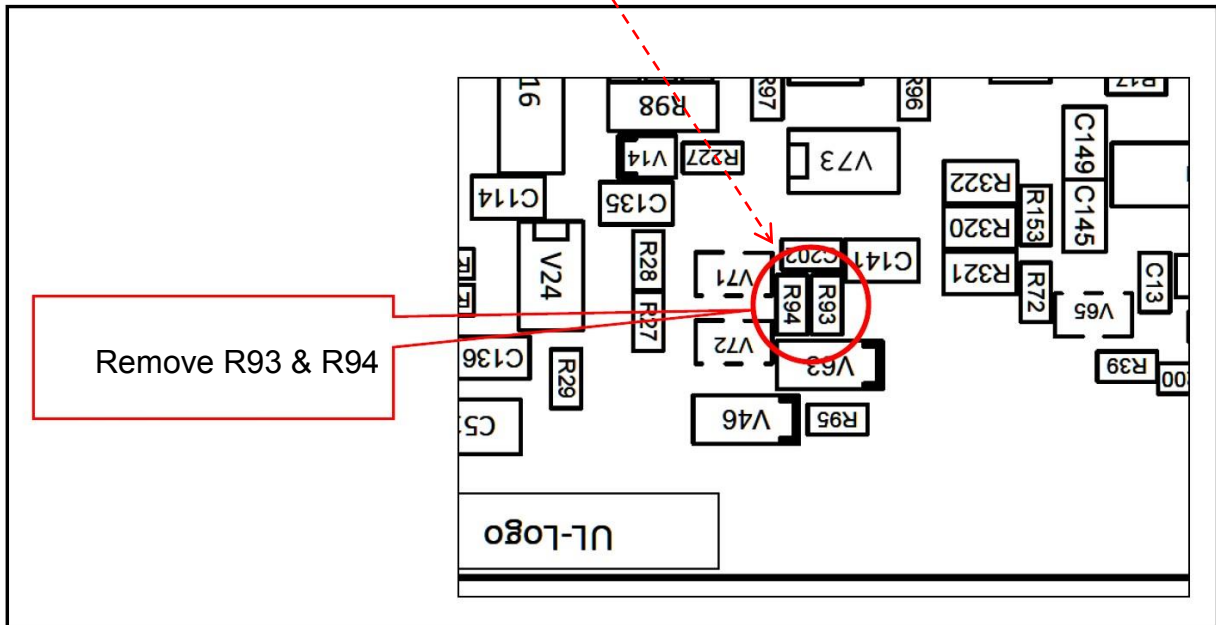
5) SMT resistors R93/94 are located in red circle shown below:

Removal of two (2) surface mount resistors, R93 and R94, will correct this problem:

6) After removal of R93 & R94, re-install all covers. Instrument does NOT require recalibration after the removal of R93 & R94.
