N9038A-05

S E R V I C E N O T E

N9038A MXE EMI Receiver

Reduce Unspecified Residual Responses Between 400 and 600 MHz

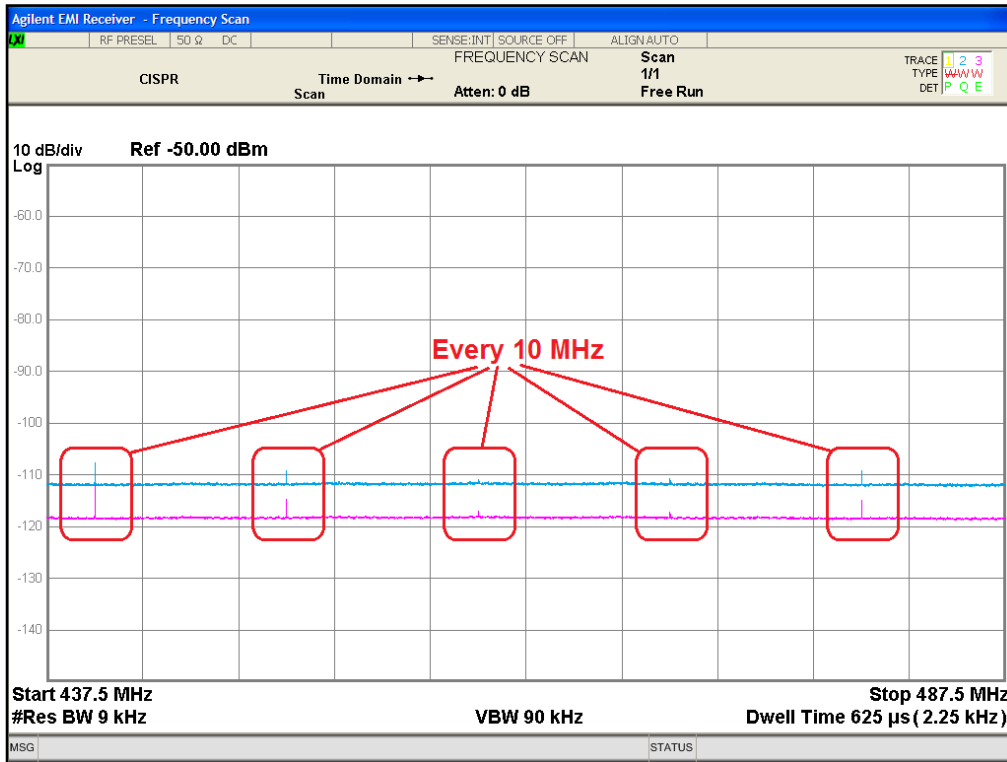
Figure 1 - Residual Responses

Some instruments have displayed residual responses due to multiples of the 10 MHz internal reference getting into the A22 Radiated Filter Board assembly, as shown in Figure 1. While these residual responses have never been seen high enough to violate any advertised instrument specification some users have reported that they interfere with the testing of their products.

These residual responses are typically only seen when using the time domain scan type (Option TDS) in the EMI Receiver mode, along with the use of one of the EMI detectors (Quasi-Peak, EMI Average, or RMS Average) and a narrower than normal resolution bandwidth. Without this combination of settings the residuals will most likely not be seen at all, and sometime not even seen when these settings are used on a large percentage of instruments. Since the time domain scan type is an FFT measurement the level of residual responses when using it are not specified, we only provide a nominal value of -100 dBm for this case.

To perform this modification two resistors will need to be changed on the A22 Radiated Filter board assembly and two capacitors will need to be added.
