N9913A-01

S E R V I C E N O T E

N9913A - FieldFox Handheld Analyzer

March 21, 2013

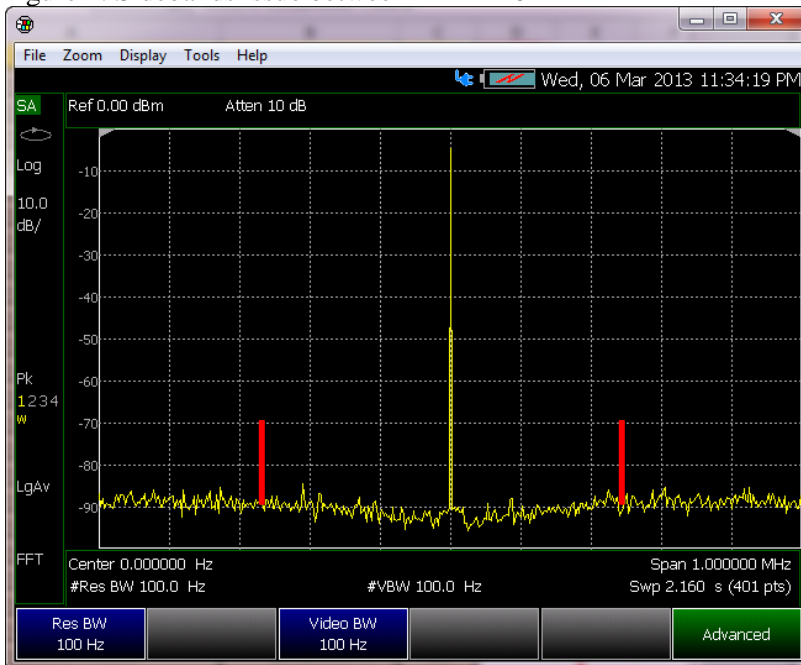
RF board earlier than Rev 7 may have sidebands issue due to oscillation by the voltage regulator. After it is fixed by replacing a new inductor, the RF board revision header will be updated to reflect the change.

Figure 2: Sidebands issue between 112 - 116 kHz

Affected FieldFox are required to send back to Agilent factory for RF board reliability enhancement. The RF board revision header will be updated to reflect the change. Test and Adjustment shall be done before shipping back to customer.
