N9917A-01

S E R V I C E N O T E

N9917A - FieldFox Handheld Analyzer

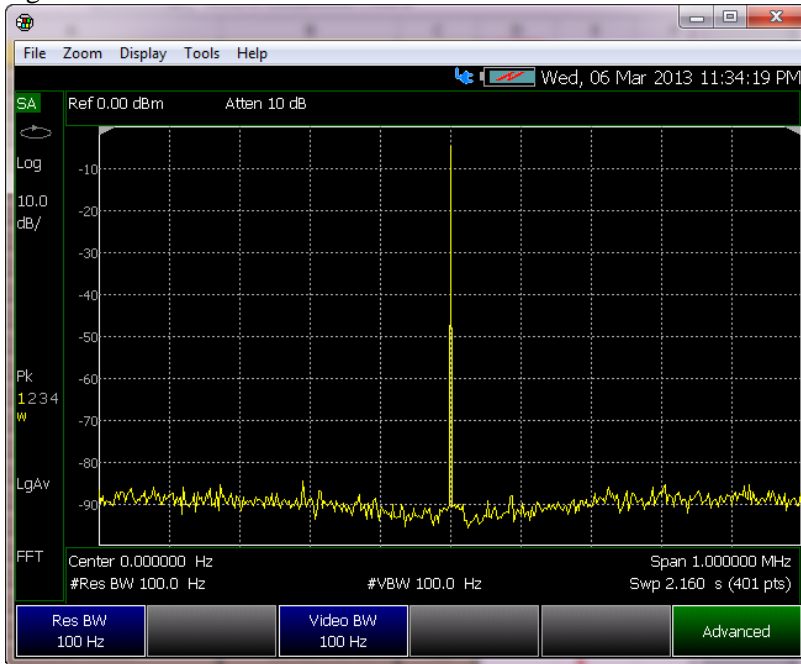
Figure 1: No sidebands issue

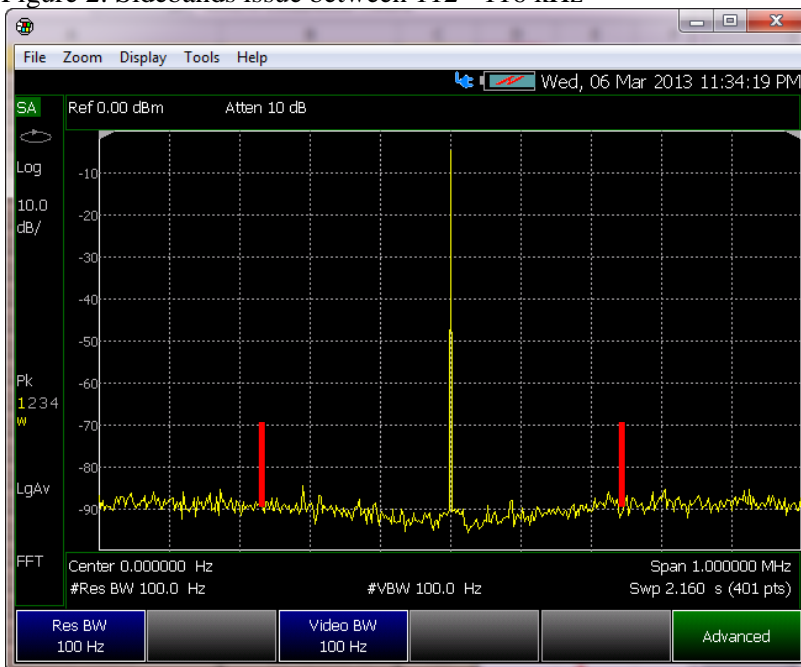
RF board earlier than Rev 7 may have sidebands issue due to oscillation by the voltage regulator. After it is fixed by replacing a new inductor, the RF board revision header will be updated to reflect the change.

Figure 2: Sidebands issue between 112 - 116 kHz

Affected FieldFox are required to send back to Agilent factory for RF board reliability enhancement. The RF board revision header will be updated to reflect the change. Test and Adjustment shall be done before shipping back to customer.
