N9935A-02

S E R V I C E N O T E

N9935A FieldFox Handheld Analyzer

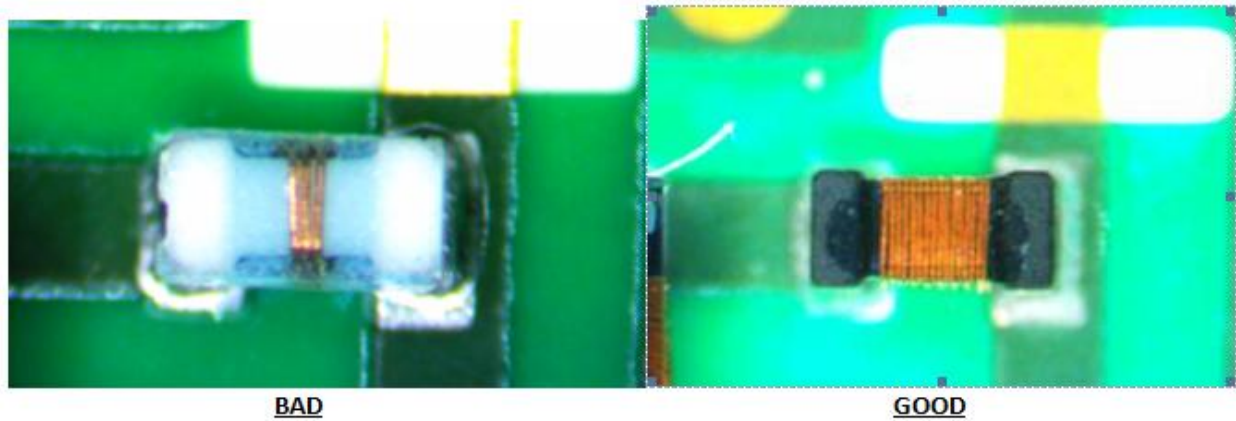
FieldFox instruments with the serial numbers listed below may show potential DANL failures with 3-4 dB difference due to misloaded inductor on the RF board. If DANL improvement is necessary, a new RF board is available to fix this it.

Figure 1: Image showing the good and bad inductor on location U678 at RF Board

Affected FieldFox with necessary DANL improvement are required to send back to Agilent factory for a new RF board replacement. Test and Adjustment shall be done before shipping back to customer.
