**S E R V I C E N O T E**

**N9936A FieldFox Handheld Analyzer**

**FieldFox instruments with the serial numbers listed on the following page may generate potential DANL failure due to different inductor being placed. A new RF board is required if DANL improvement is necessary.**

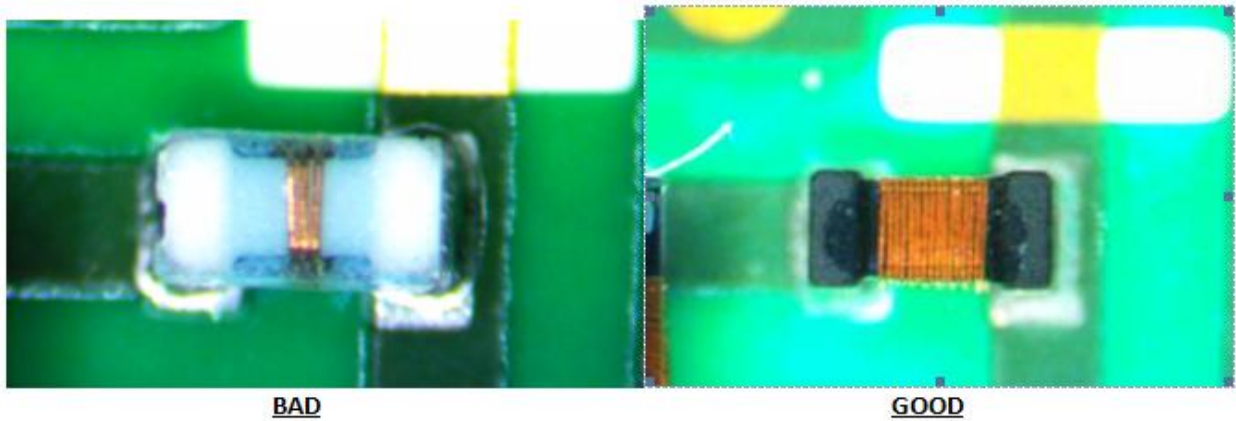
FieldFox instruments with the serial numbers listed below may show potential DANL failures with 3-4 dB difference due to misloaded inductor on the RF board. If DANL improvement is necessary, a new RF board is available to fix this it.

**Figure 1: Image showing the good and bad inductor on location U678 at RF Board**

Affected FieldFox with necessary DANL improvement are required to send back to Agilent factory for a new RF board replacement. Test and Adjustment shall be done before shipping back to customer.
