# Modification Recommended Service Note

## P5000B Keysight Streamline Vector Network Analyzer

Serial Numbers: From MY61100009 to MY61100135

Potential lifted front panel overlay

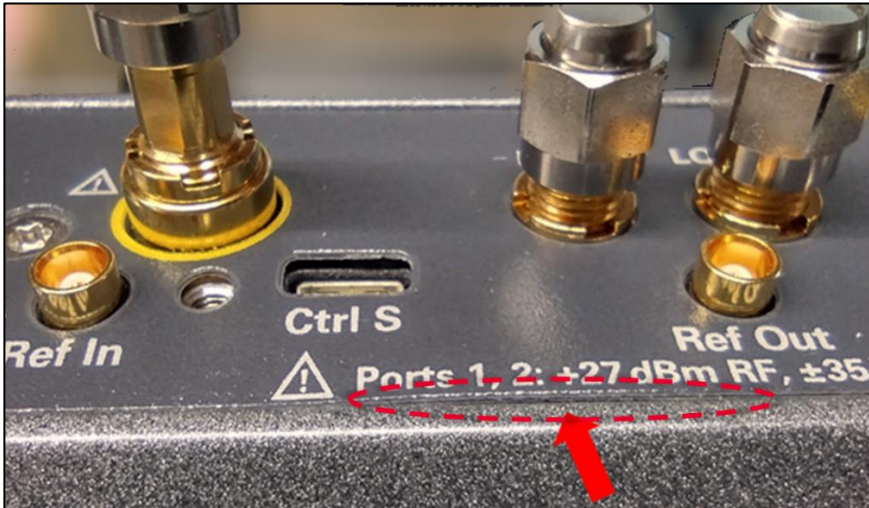
Keysight streamline series vector network analyzer (VNA) of serial number range identified in service note cover page might potentially exhibit the following lifted front panel overlay symptom.

Apart from cosmetic imperfections, the lifted front overlay could have led to non-fully attached *Ctrl S* micro-HDMI cable connector in multi-VNAs setup configuration.

-> Apply this service note only if end users' VNA is exhibiting the following symptom.

Procedure to replace the front panel overlay.

2. Pry open the existing front panel overlay and remove it from front panel.
3. Clean the metal surface thoroughly and ensure it is free of adhesive residue.
4. Affix the new self-adhesive front panel overlay onto the metal surface.
5. Reinstall (reuse) the 50-ohm terminations and port protecting caps accordingly.

6. Reinstall (reuse) the front handles.
