Modification Recommended Service Note

P5004B Keysight Streamline Vector Network Analyzer

Serial Numbers: From MY61100009 to MY61100135

Potential lifted front panel overlay

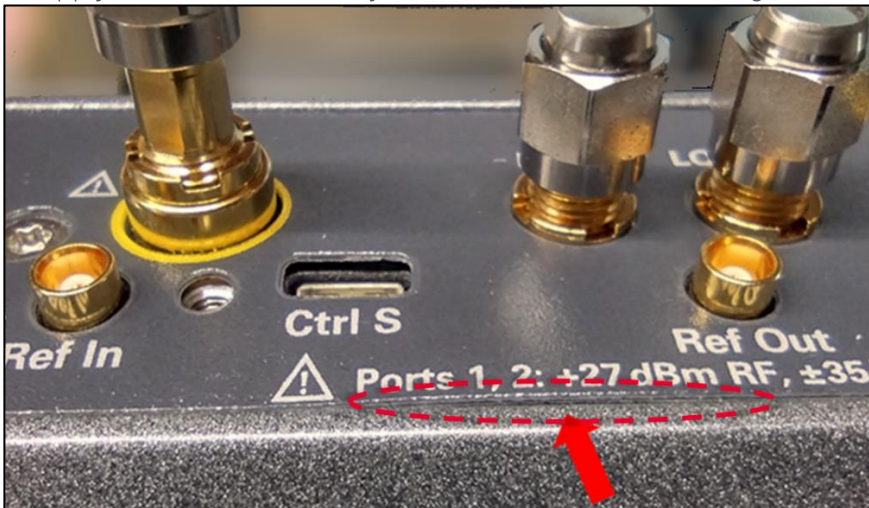
Keysight streamline series vector network analyzer (VNA) of serial number range identified in service note cover page might potentially exhibit the following lifted front panel overlay symptom.

Apart from cosmetic imperfections, the lifted front overlay could have led to non-fully attached *Ctrl S* micro-HDMI cable connector in multi-VNAs setup configuration.

-> Apply this service note only if end users' VNA is exhibiting the following symptom.

Procedure to replace the front panel overlay.

2. Pry open the existing front panel overlay and remove it from front panel.
3. Clean the metal surface thoroughly and ensure it is free of adhesive residue.
4. Affix the new self-adhesive front panel overlay onto the metal surface.
5. Reinstall (reuse) the 50-ohm terminations and port protecting caps accordingly.
