P5020A-03A-S

# Safety Service Note

## P5020A Keysight Streamline USB Vector Network Analyzer

“POTENTIAL BURN INJURY (HIGH TEMPERATURE) HAZARD”

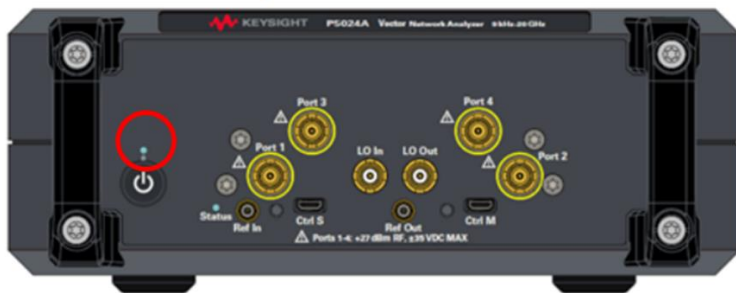
Potential presence of high temperature on front panel & chassis.  
Earlier versions of firmware have potential risk of overheating, due to thermal fan control malfunction.  
As a result, user may experience first degree epidermis burns on hand/ finger if in contact with the front panel & chassis.

VNA fails to start with the following symptoms.

1. LED indicator (below circle) turns red.
2. cooling fan does not work
3. If user leaves the VNA with this LED indicator red without turning off power switch, it continues to overheat and becomes too hot.

Solution-1: Update VNA firmware by user

Solution-2: Perform Performance Verification by Keysight

**Action-1:** Updating the firmware eliminates this potential risk of overheating.

1. **Install the latest VNA firmware Rev. A.15.55.14 or newer** on users' controller PC(s).  
The latest firmware enhanced the thermal fan control mechanism.
2. Once the latest firmware is installed, proceed with the restart of both **controller PC** and **VNA**.
3. Launch the VNA firmware. Ensure VNA powers up and launches into firmware correctly after firmware update is done.
