P5021A-03A-S

# Safety Service Note

## P5021A Keysight Streamline USB Vector Network Analyzer

“POTENTIAL BURN INJURY (HIGH TEMPERATURE) HAZARD”

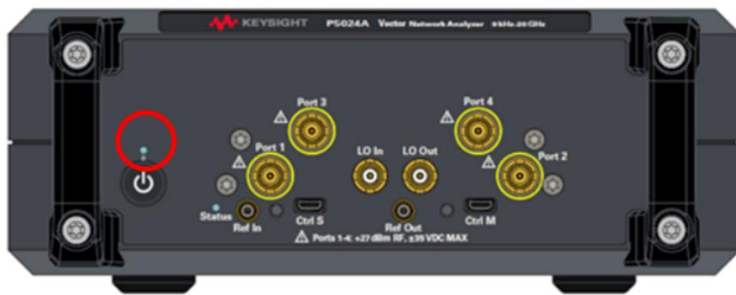
Potential presence of high temperature on front panel & chassis.  
Earlier versions of firmware have potential risk of overheating, due to thermal fan control malfunction.  
As a result, user may experience first degree epidermis burns on hand/ finger if in contact with the front panel & chassis.

VNA fails to start with the following symptoms.

1. LED indicator (below circle) turns red.
2. cooling fan does not work
3. If user leaves the VNA with this LED indicator red without turning off power switch, it continues to overheat and becomes too hot.

Solution-1: Update VNA firmware by user

1. **Install the latest VNA firmware Rev. A.15.55.14 or newer** on users' controller PC(s).  
The latest firmware enhanced the thermal fan control mechanism.
2. Once the latest firmware is installed, proceed with the restart of both **controller PC** and **VNA**.
3. Launch the VNA firmware. Ensure VNA powers up and launches into firmware correctly after firmware update is done.
