P5023A-03B-S

# Safety Service Note

## P5023A Keysight Streamline USB Vector Network Analyzer

“POTENTIAL BURN INJURY (HIGH TEMPERATURE) HAZARD”

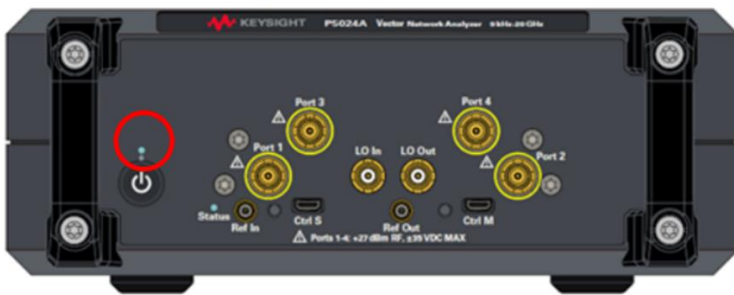
VNA fails to start with the following symptoms.

- 1. LED indicator (below circle) turns red.
- 2. cooling fan does not work
- 3. If user leaves the VNA with this LED indicator red without turning off power switch, it continues to overheat and becomes too hot.

Solution-1: Update VNA firmware by user

Solution-2: Perform Performance Verification by Keysight
