P5024A-05A

# Information Only Service Note

## P5024A Keysight Streamline USB Vector Network Analyzer

Firmware update requirement to A.15.60.08 or newer for P5024A with MY582, SG582 serial prefix.

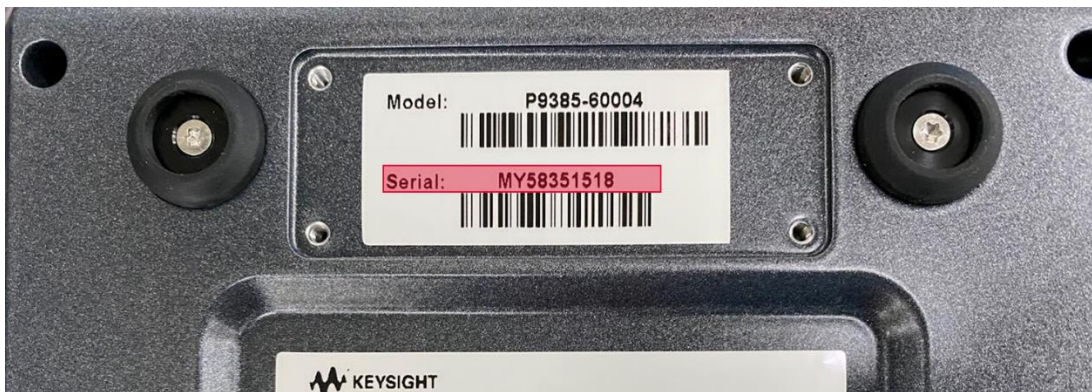
To identify the chassis generation, refer to the hardware serial number break as follows.

| HW generation | Chassis Serial number |
| Old | MY58351xxx and below<br>MY58353xxx and above |
| New | MY58352xxx |

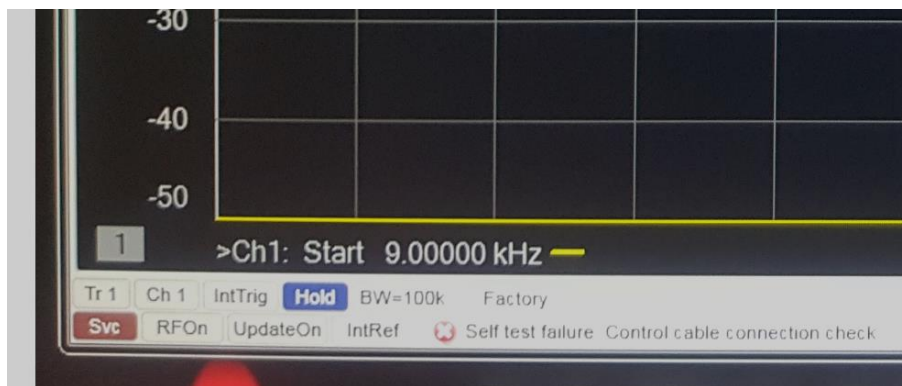
Listed are the known limitations if older firmware revision is used on the new chassis hardware.

1. 10MHz Ref-In (VNA front panel) fails to lock with external reference input signal.
2. On dual source VNA (P502xA option 402), firmware will prompt false alarm on self-test failure on cable connection check.

When the above symptom is discovered, update the user controller's PC firmware revision to A.15.60.08 or newer.

If end user would like to retain the existing firmware revision, the work around is to update the IVI drivers manually.
