P5026A-03-S

# Safety Service Note

## P5026A Keysight Streamline USB Vector Network Analyzer

### “POTENTIAL BURN INJURY (HIGH TEMPERATURE) HAZARD”

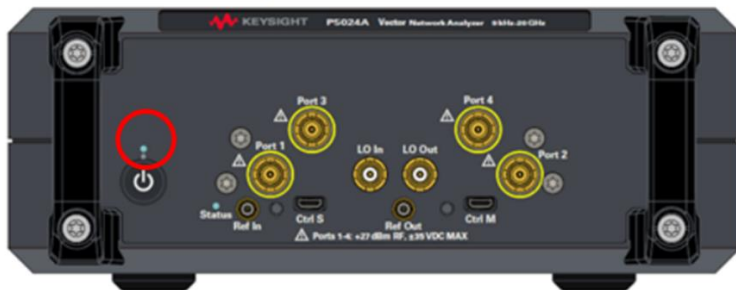
VNA fails to start with the following symptoms.

1. LED indicator (below circle) turns red.
2. cooling fan does not work
3. If user leaves the VNA with this LED indicator red without turning off power switch, it continues to overheat and becomes too hot.

Solution-1: Update VNA firmware by user

Solution-2: Perform Performance Verification by Keysight

1. **Install the latest VNA firmware Rev. A.15.40.13 or newer on users' controller PC(s).**  
The latest firmware enhanced the thermal fan control mechanism.
2. Once the latest firmware is installed, proceed with the restart of both **controller PC** and **VNA**.
3. Launch the VNA firmware. Ensure VNA powers up and launches into firmware correctly after firmware update is done.
