P5026A-05A

# Information Only Service Note

## P5026A Keysight Streamline USB Vector Network Analyzer

Firmware update requirement to A.15.60.08 or newer for P5026A with MY582, SG582 serial prefix.

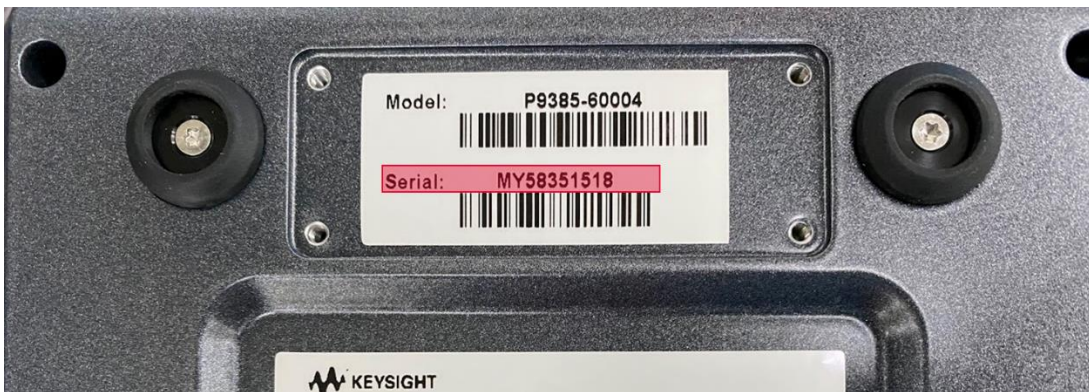
To identify the chassis generation, refer to the hardware serial number break as follows.

HW generation	Chassis Serial number
Old	MY58351xxx and below MY58353xxx and above
New	MY58352xxx
