Modification Recommended Service Note

P9370B Keysight Streamline Vector Network Analyzer

Serial Numbers: From MY61100288 to MY61100353

Potential lifted front panel overlay

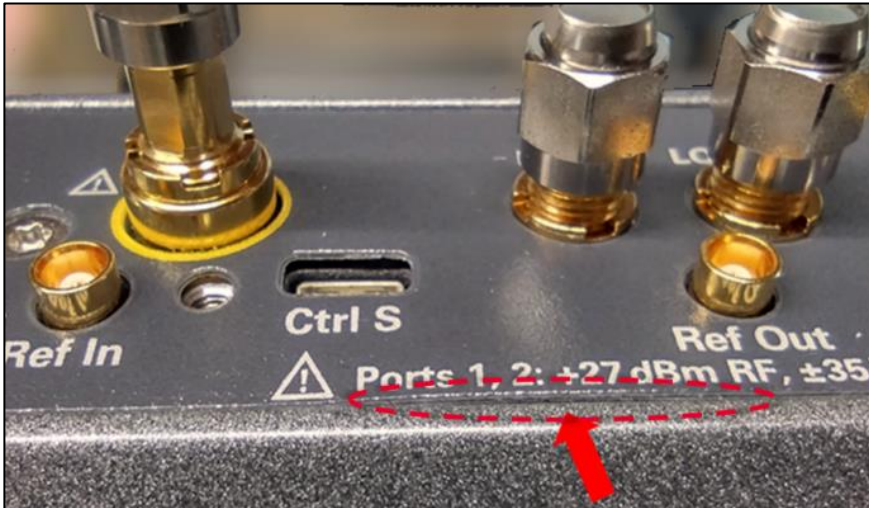
Keysight streamline series vector network analyzer (VNA) of serial number range identified in service note cover page might potentially exhibit the following lifted front panel overlay symptom.

Apart from cosmetic imperfections, the lifted front overlay could have led to non-fully attached *Ctrl S* micro-HDMI cable connector in multi-VNAs setup configuration.

-> Apply this service note only if end users' VNA is exhibiting the following symptom.

Procedure to replace the front panel overlay.

2. Pry open the existing front panel overlay and remove it from front panel.
3. Clean the metal surface thoroughly and ensure it is free of adhesive residue.
4. Affix the new self-adhesive front panel overlay onto the metal surface.
5. Reinstall (reuse) the 50-ohm terminations and port protecting caps accordingly.
