P9372A-03

Information Only Service Note

P9372A Vector Network Analyzer, 300 kHz to 9 GHz, 2-port

Firmware update requirement to A.15.75.22 or newer for P9372A with MY573, SG573 serial prefix.

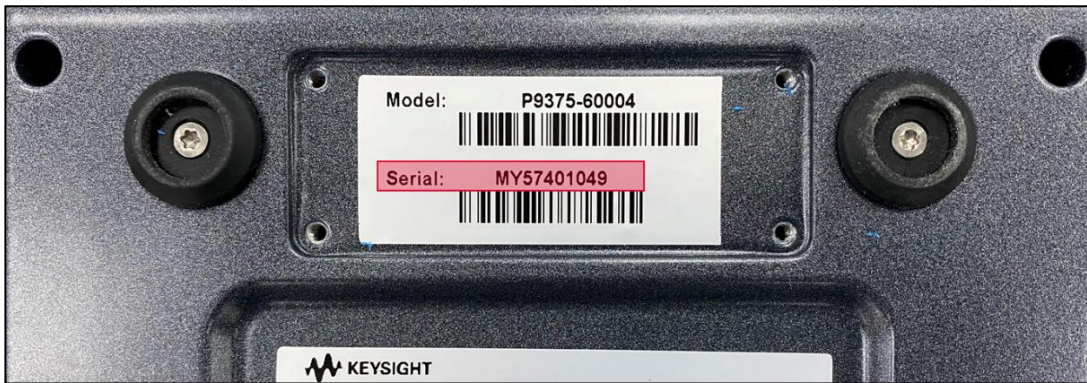
For repaired P937xA, to identify the chassis generation, refer to the hardware serial number break as follows. Shown below is an example of MY574 HW serial number with old chassis HW.

HW generation	Chassis Serial number
Old	MY574xxxxx
New	MY575xxxxx
