P9373A-03

Information Only Service Note

P9373A Vector Network Analyzer, 300 kHz to 14 GHz, 2-port

Firmware update requirement to A.15.75.22 or newer for P9373A with MY573, SG573 serial prefix.

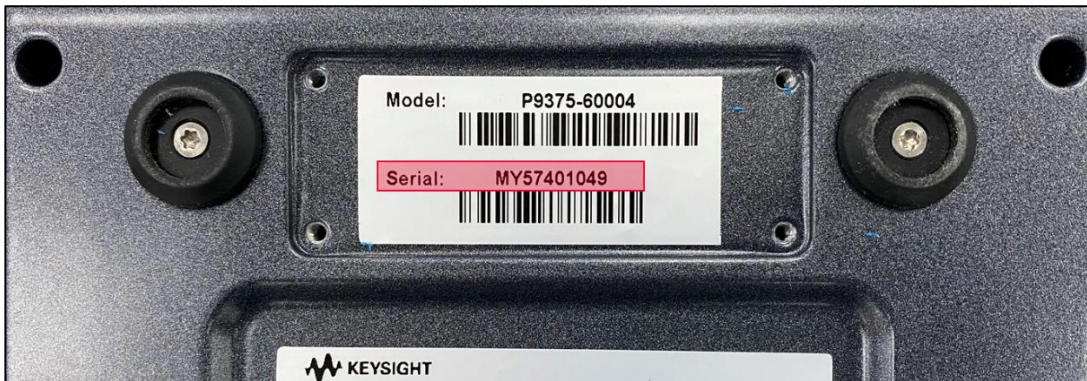
For repaired P937xA, to identify the chassis generation, refer to the hardware serial number break as follows. Shown below is an example of MY574 HW serial number with old chassis HW.

HW generation	Chassis Serial number
Old	MY574xxxxx
New	MY575xxxxx
