P9375A-02

Information Only Service Note

P9375A Vector Network Analyzer, 300 kHz to 26.5 GHz, 2-port

Firmware update requirement to A.15.75.22 or newer for P9375A with MY573, SG573 serial prefix.

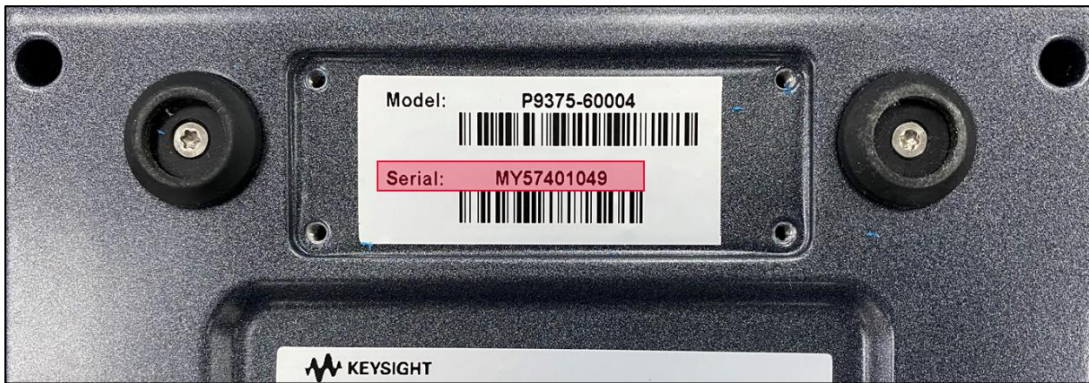
For repaired P937xA, to identify the chassis generation, refer to the hardware serial number break as follows. Shown below is an example of MY574 HW serial number with old chassis HW.

HW generation	Chassis Serial number
Old	MY574xxxxx
New	MY575xxxxx
