Modification Recommended Service Note

P9375B Keysight Streamline Vector Network Analyzer

Serial Numbers: From MY61100288 to MY61100353

Potential lifted front panel overlay

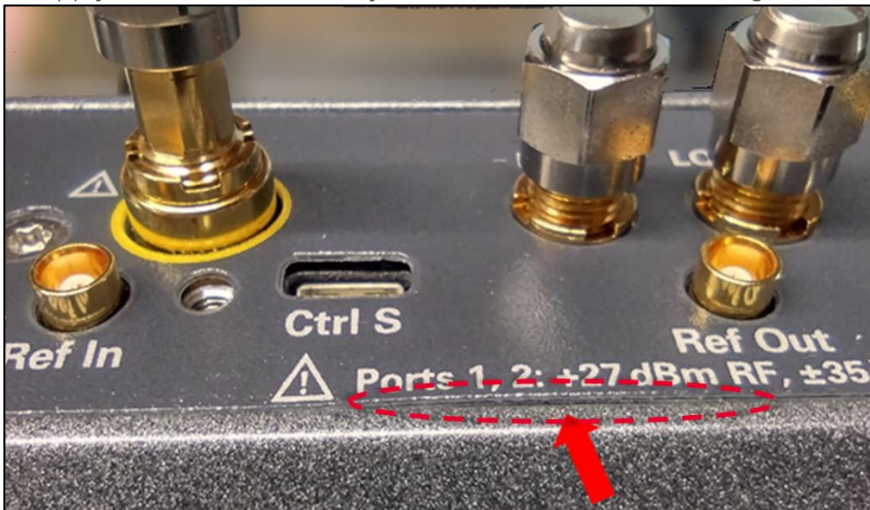
Keysight streamline series vector network analyzer (VNA) of serial number range identified in service note cover page might potentially exhibit the following lifted front panel overlay symptom.

Apart from cosmetic imperfections, the lifted front overlay could have led to non-fully attached *Ctrl S* micro-HDMI cable connector in multi-VNAs setup configuration.

-> Apply this service note only if end users' VNA is exhibiting the following symptom.

Procedure to replace the front panel overlay.

2. Pry open the existing front panel overlay and remove it from front panel.
3. Clean the metal surface thoroughly and ensure it is free of adhesive residue.
4. Affix the new self-adhesive front panel overlay onto the metal surface.
5. Reinstall (reuse) the 50-ohm terminations and port protecting caps accordingly.

6. Reinstall (reuse) the front handles.
