T1250A-02

Modification Recommended Service Note

T1250A - Smart RF Switching Unit

Serial Numbers: E1250000001/E1250000014, ES53210101, EST12500013/EST12500028,
MY53301001/MY54050147

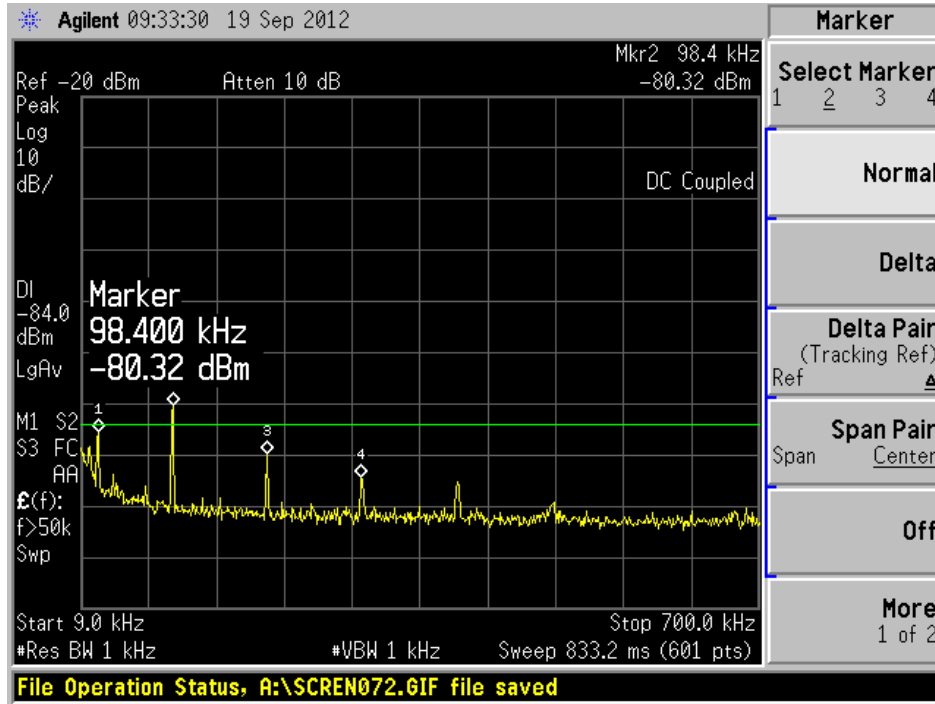
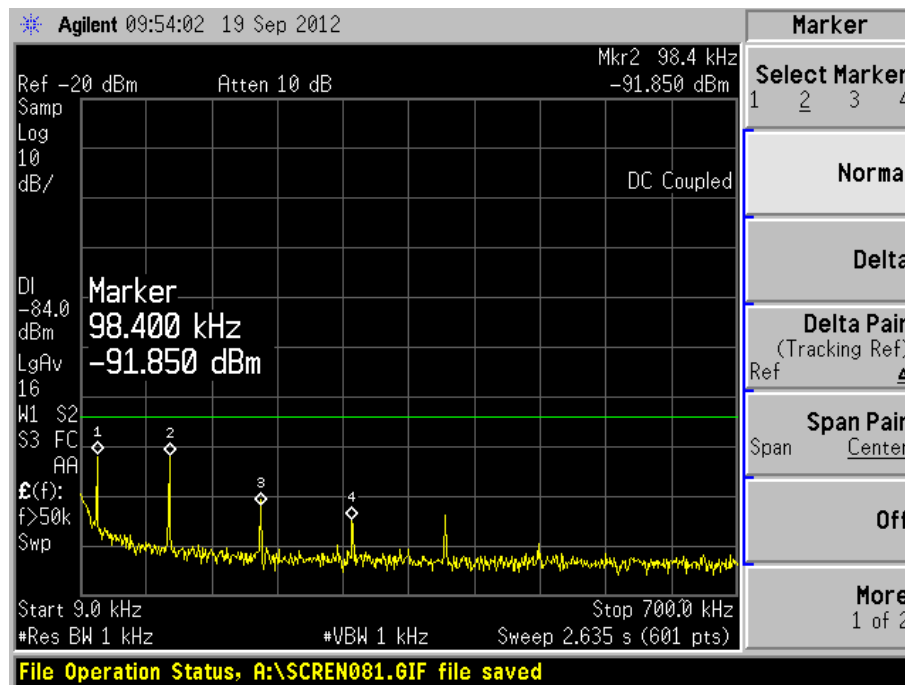
Some spurious were found at frequency 98.4 KHz and its harmonics (196.8 KHz, 295.2 KHz...), which come from the T1250A Power Supply Unit. In some cases, the main 98.4 KHz spurious could be measured above the threshold level of the 3GPP test case 6.6.3.1 (“Transmitter spurious emissions”), thus producing a ‘ false’ spurious (it does not come from the UE under test).

Note: The spurious at 20 KHz (in the screenshots) is not generated by the PSU (it came from the Test Bench).

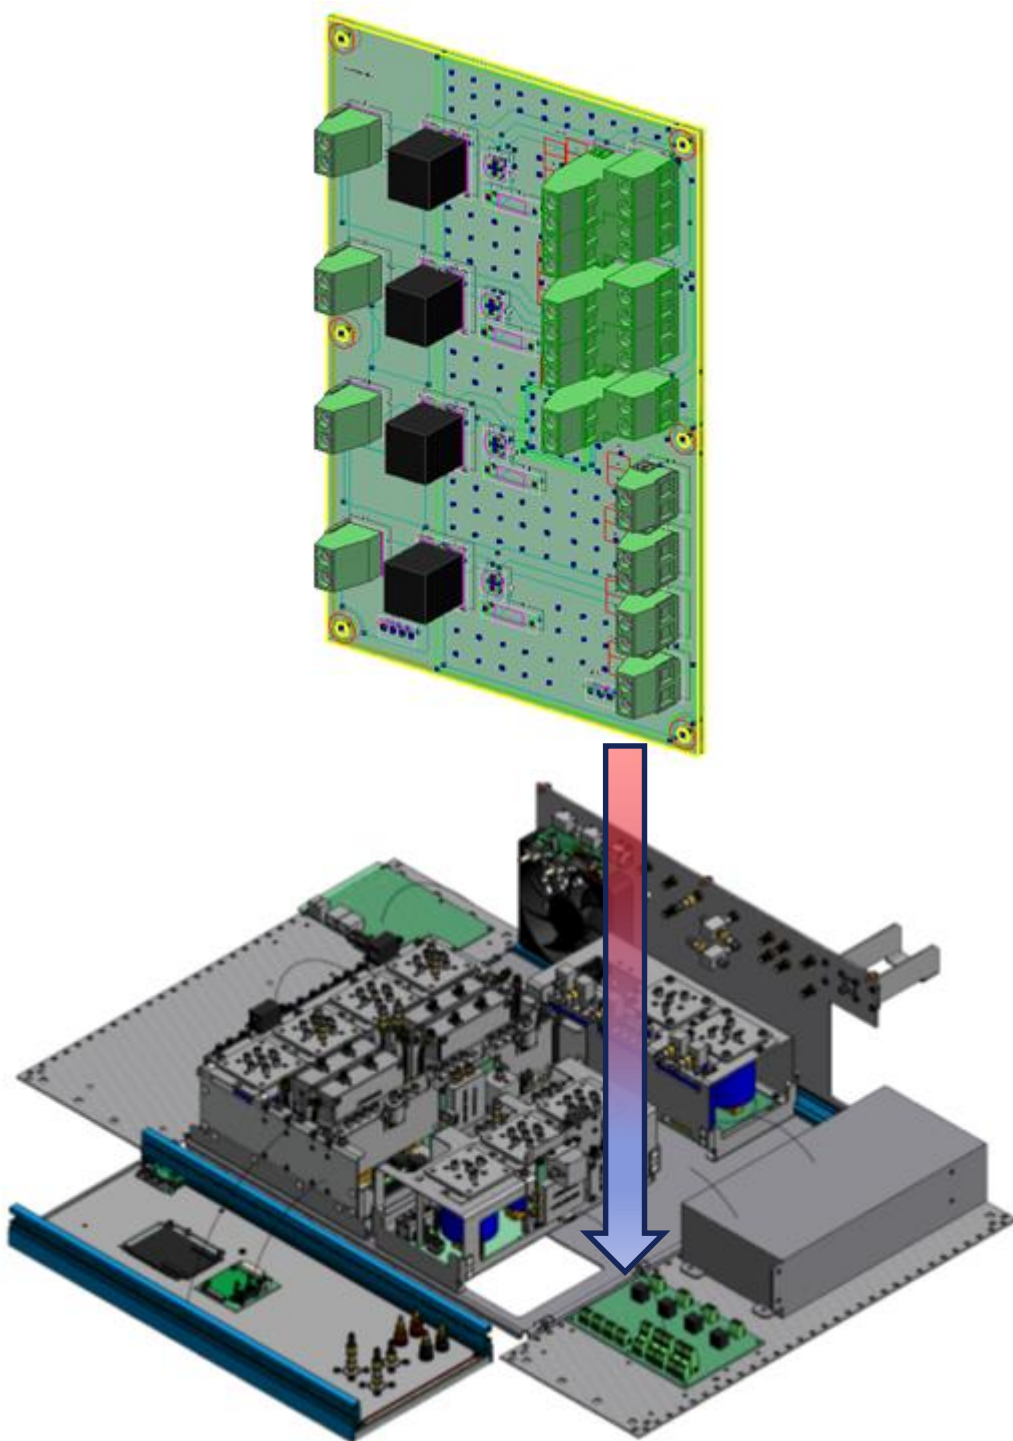
The following picture shows the Power Distribution Board (T1250-60009), and its location in the T1250A:

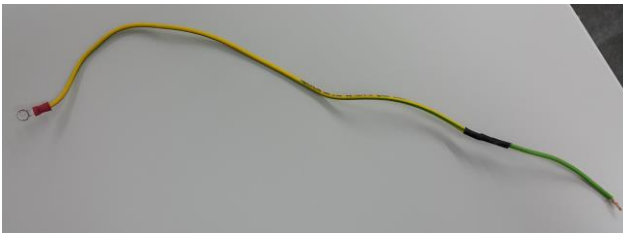
AWG18 and 35 cm long ground cable

- i. Open upper cover of T1250A
- ii. Remove the GND cable “T1250-21001” (obsolete version) that goes from J4 connector of the Power Distribution Board “T1250-60009” to chassis:

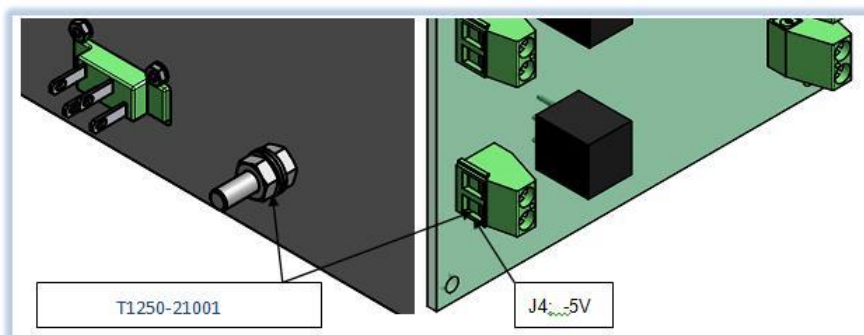
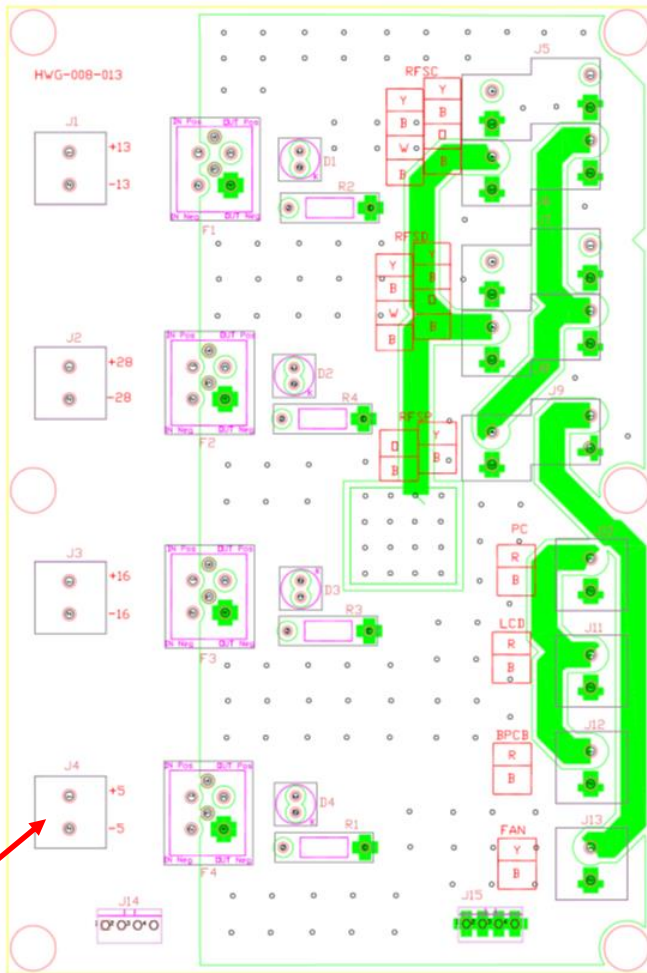
Layout of Power Distribution Board T1250-60009, highlighting “J4” connector

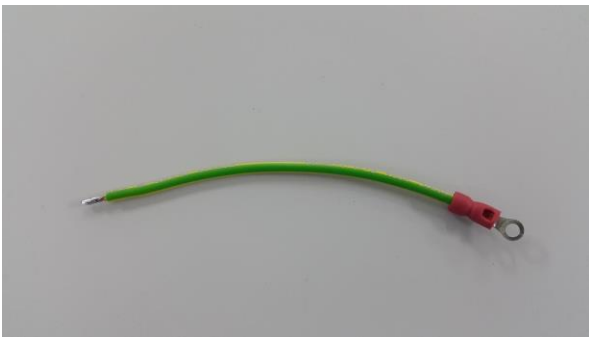
AWG16 and 10 cm long ground cable

- iii. Connect the cable “T1250-21001” (new version) from J4 of the Board “T1250-60009” to the chassis screw of the same board as shown in the following Pictures:
