U1273AX-06

Information Only Service Note

U1273AX Handheld Digital Multimeter, 4½ Digit, IP54, OLED Display, -40°C

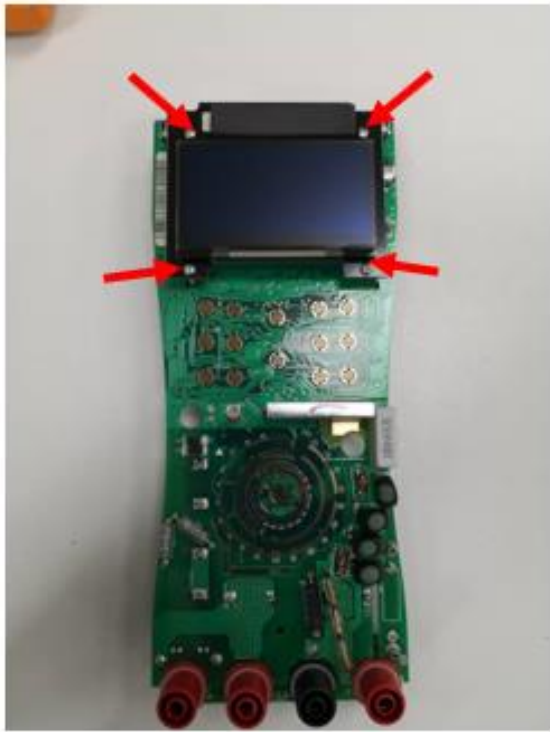
Once you find that the OLED display of your Handheld Digital Multimeter (HHDMM) is dimmer than usual or no display, and there is a beeping sound, replacing the OLED display board will solve the problem.

7. Replace OLED display board by unscrewing the 4 screws.
