**U2000A-03**

**S E R V I C E N O T E**

U2000A 10MHz – 18GHz USB Sensor

**Difficulty to attach USB power sensor cable to power sensor unit.**

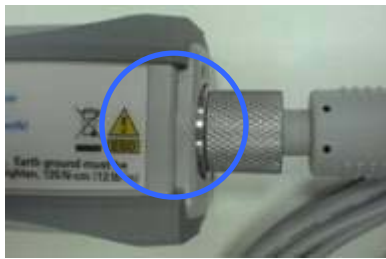
Figure 1: USB power sensor cable fully attached to power sensor unit
