U9405A-02

S E R V I C E N O T E

U9405A - i1000SFP systems

Current Digital card firmware version 06 does not support i2C/SPI “Read to File” function.

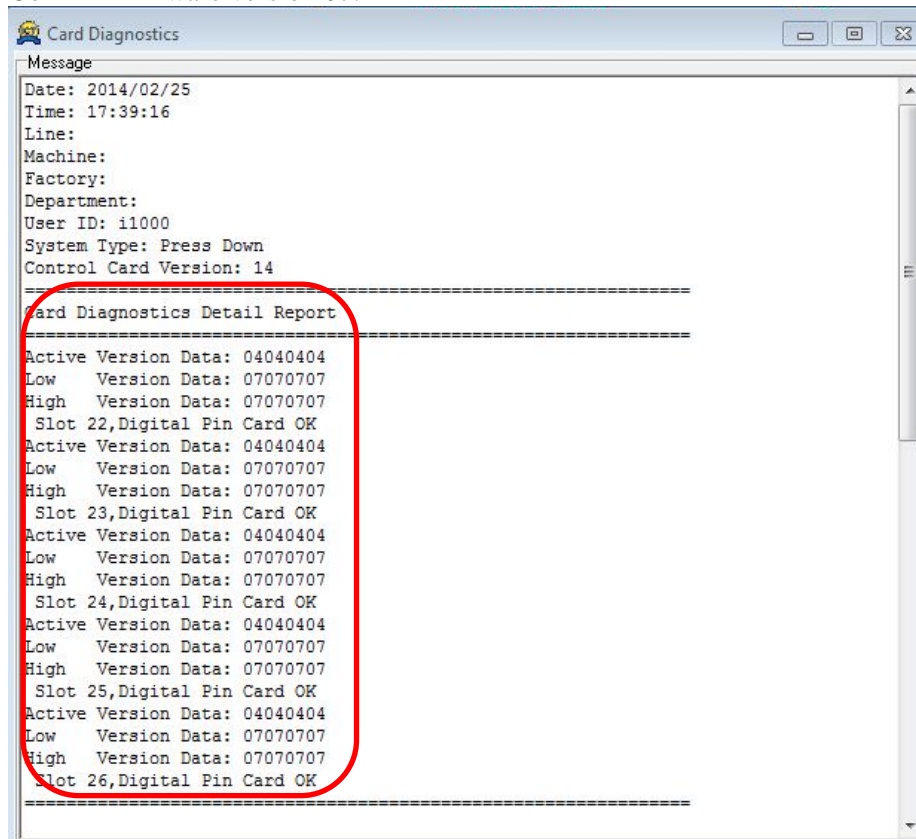
Low = "07|07 |07|07" to represent the 4xLow Channel IC Firmware
 High = "07|07 |07|07" to represent the 4xHigh Channel IC Firmware

2. Confirm firmware version 07.
