U9405B-02

Modification Recommended Service Note

U9405B - FlexiCore Parallel ICT and FlexiCore FlashStation

The Problem – Handler Control Panel cannot detect Fixture Control Board sensors states

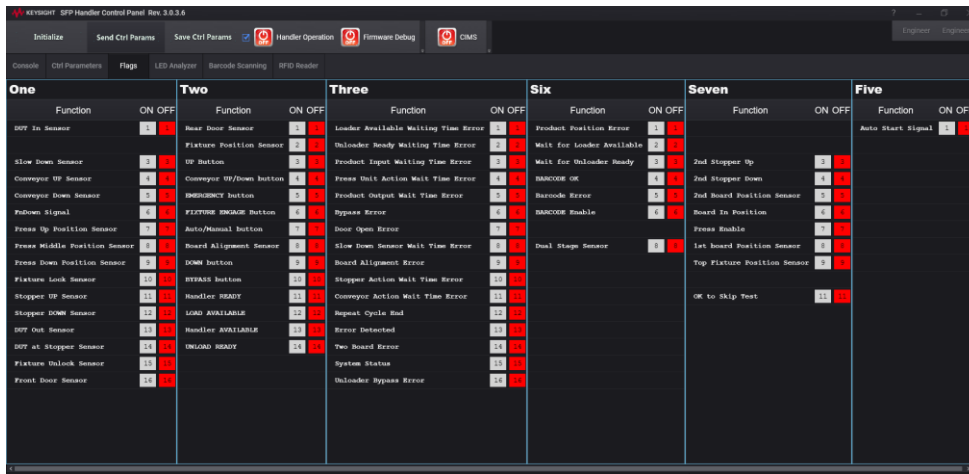
The change causes all versions of Handler Control Panel application to lose communications to the firmware. Handler Control Panel can no longer detect the states of the sensors from the Fixture Control Board. However, certain operations like Initialize still works.

Handler Control Panel version 3.0.4.0 (HCPv3040) has been released to fix the problem. Handler Command version 1.2.8.3 has been released to support the new features of HCPv3040. Send an email request to kwan-wee_lee@keysight.com for the download links.

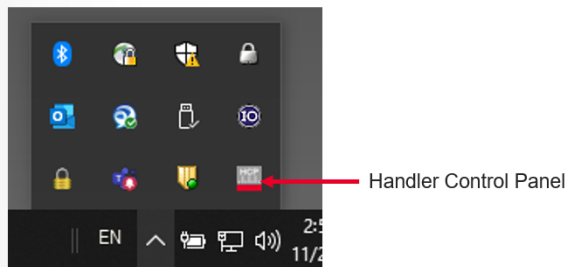
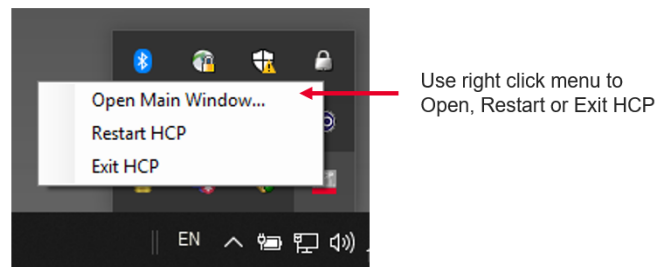
Application startup

HCPv3040 starts up into the system tray and does not display its main interface by default. This is to minimize clutter on the windows desktop. User may go to the system tray to bring up the main interface if needed. When terminating HCP, user will need to exit the application from the system tray too. Clicking the “X” icon on the main interface does not terminate the application.

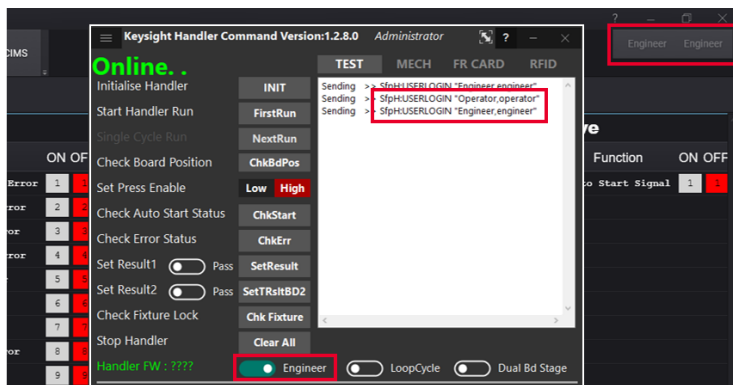
Engr/Opr access control

To prevent unauthorized access to the control of the handler, HCPv3040 will startup in Operator mode by default. In this mode, user can only view the states of the sensors and cannot perform any handler operations such as Initialize or Conveyor Width adjustments.

The only way to unlock HCP into Engineer mode is via a command to the HCP SCPI server. To do this, user just need to launch the Handler Command application in Administrator mode and the application will automatically send the command to set HCP into Engineer mode. User can then toggle between Operator and Engineer mode from the Handler Command interface.

HCP starts into Operator access

Requires `USERLOGIN cmd` to change access level

Username can be customised to any name

Supports only “engineer” and “operator” levels.

Users are recommended to make use of the Handler Command application to perform any handler operations such as Initialization and Conveyor Width adjustments. The application also provides a range of other actions and features which will help in system setup or troubleshooting. User can access the documentation for Handler Command by clicking the “?” icon on its interface.
